ADDENDUM NO. 1
February 28, 2023
225107

RE: ALBURGH VILLAGE WATER TANK REPLACEMENT

DECEMBER 17, 2009

***INSPECTION AND CLEANING OF THE VANTINE AVENUE
200,000-GALLON ELEVATED WELDED STEEL WATER STORAGE TANK***

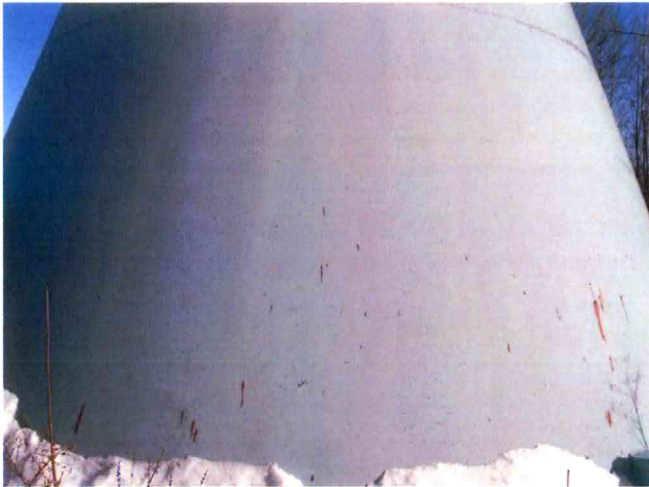
The protective coating applied to these surfaces shows decline in film thickness, caused by weathering and near expiration. This condition has caused the coating to become chalky throughout all elevations of the tank.

Numerous coating chips, ranging from 1/8" to 1" in diameter, exist throughout approximately 25% of the lowest 30' of the pedestal and cause exposure of the primer and the underlying steel.

These coating chips appear to be the result of objects striking the pedestal and cause mild surface corrosion at this time.

1 *Exterior Wall & Bowl Surfaces Found With Nearly Expired Chalky Coating, Chips Throughout Lowest 30' Of The Pedestal And Mildew Throughout The Underside Of The Bowl*

We recommend re-coating all exterior wall and roof surfaces in an effort to protect and maintain the integrity of the steel and improve the overall aesthetic value of the structure.

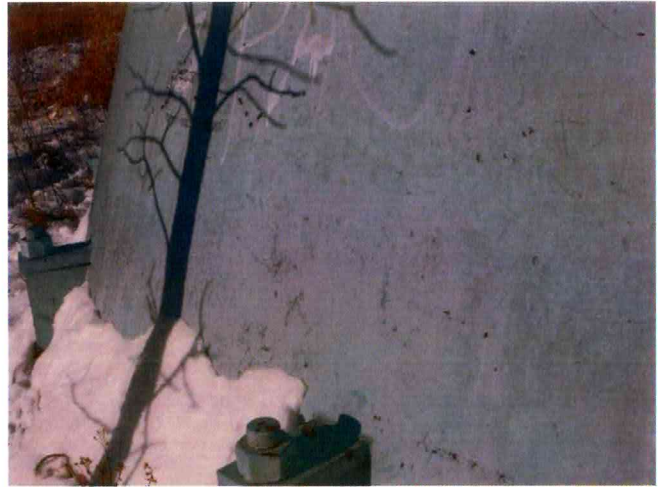
2 *Exterior Wall & Bowl Surfaces Found With Nearly Expired Chalky Coating, Chips Throughout Lowest 30' Of The Pedestal And Mildew Throughout The Underside Of The Bowl*

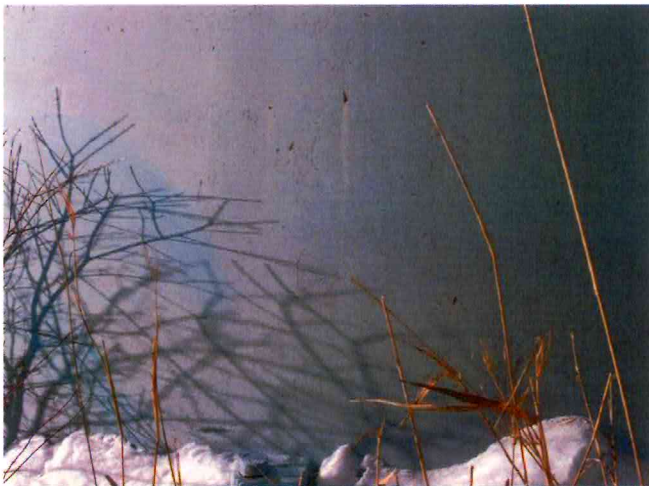
3 *Exterior Wall & Bowl Surfaces Found With Nearly Expired Chalky Coating, Chips Throughout Lowest 30' Of The Pedestal And Mildew Throughout The Underside Of The Bowl*

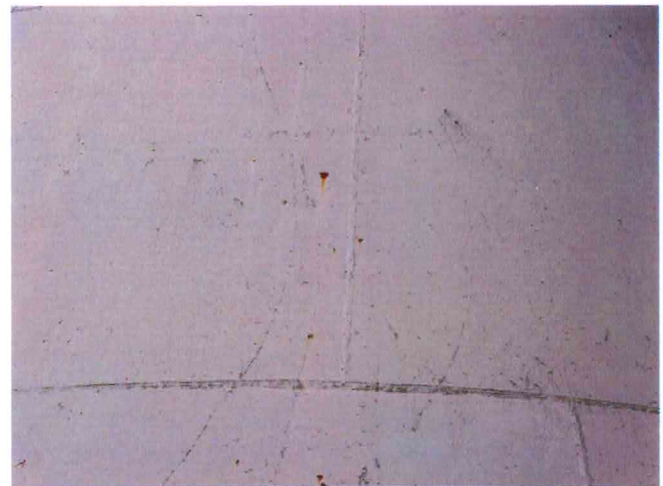
4 *Exterior Wall & Bowl Surfaces Found With Nearly Expired Chalky Coating, Chips Throughout Lowest 30' Of The Pedestal And Mildew Throughout The Underside Of The Bowl*

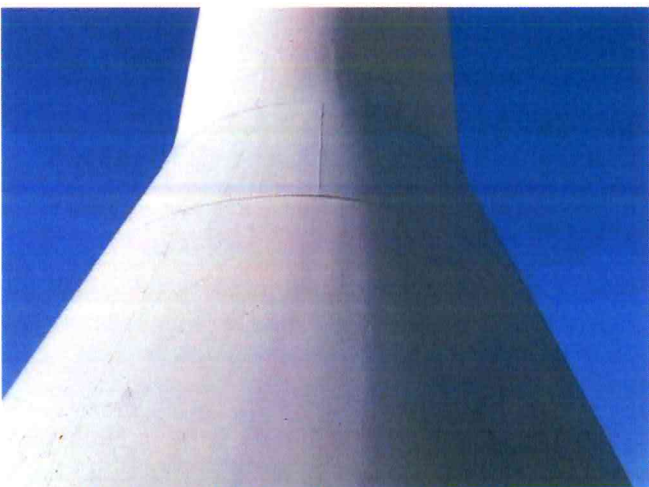
5 *Exterior Wall & Bowl Surfaces Found With Nearly Expired Chalky Coating, Chips Throughout Lowest 30' Of The Pedestal And Mildew Throughout The Underside Of The Bowl*

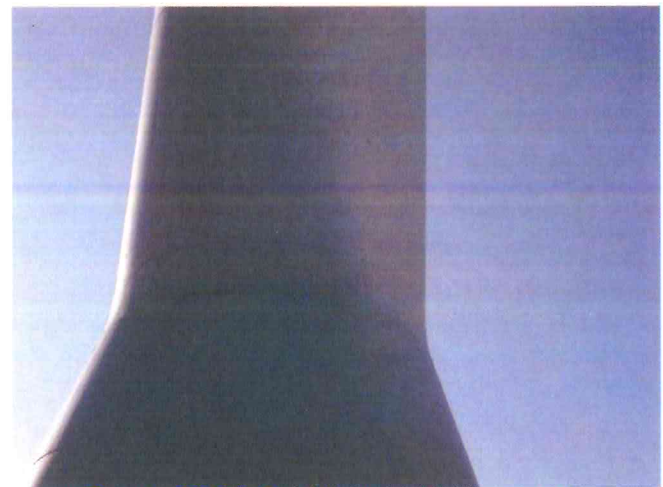
6 *Exterior Wall & Bowl Surfaces Found With Nearly Expired Chalky Coating, Chips Throughout Lowest 30' Of The Pedestal And Mildew Throughout The Underside Of The Bowl*

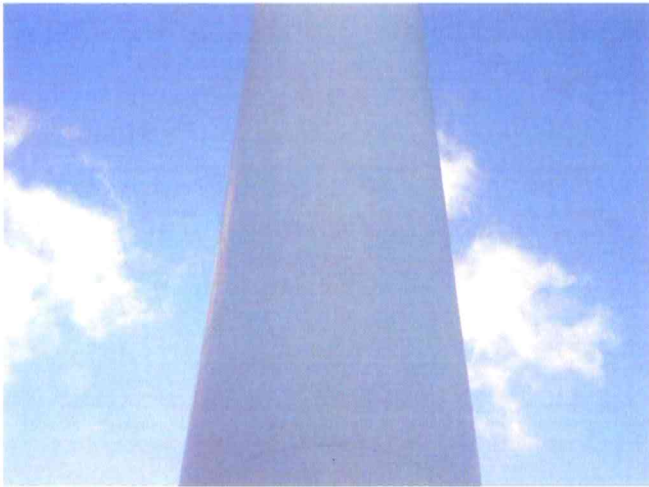
7 *Exterior Wall & Bowl Surfaces Found With Nearly Expired Chalky Coating, Chips Throughout Lowest 30' Of The Pedestal And Mildew Throughout The Underside Of The Bowl*

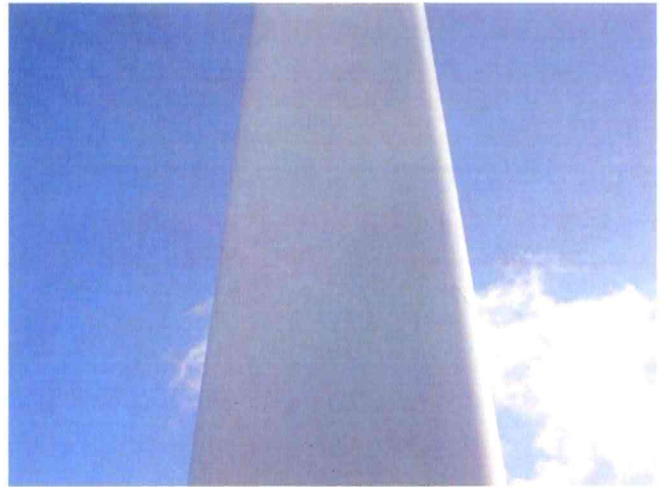
8 *Exterior Wall & Bowl Surfaces Found With Nearly Expired Chalky Coating, Chips Throughout Lowest 30' Of The Pedestal And Mildew Throughout The Underside Of The Bowl*

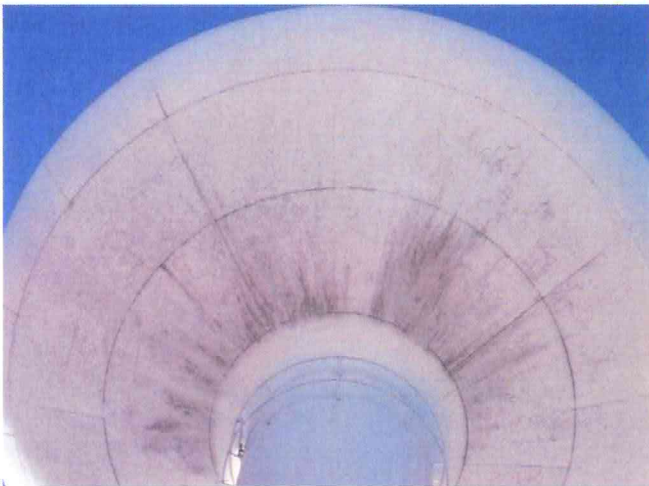
9 *Exterior Wall & Bowl Surfaces Found With Nearly Expired Chalky Coating, Chips Throughout Lowest 30' Of The Pedestal And Mildew Throughout The Underside Of The Bowl*

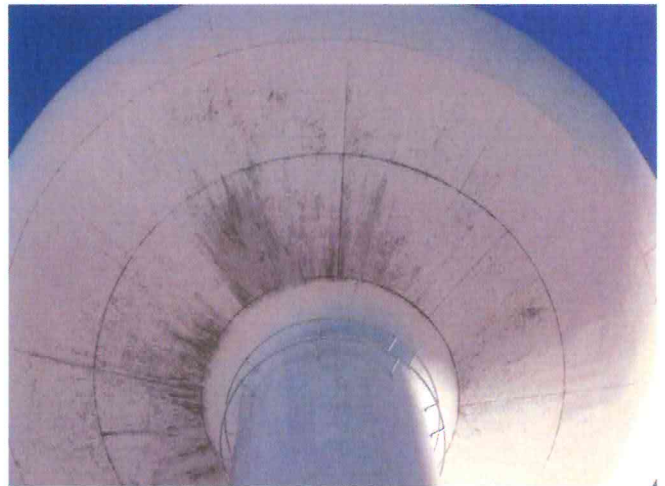
10 *Exterior Wall & Bowl Surfaces Found With Nearly Expired Chalky Coating, Chips Throughout Lowest 30' Of The Pedestal And Mildew Throughout The Underside Of The Bowl*

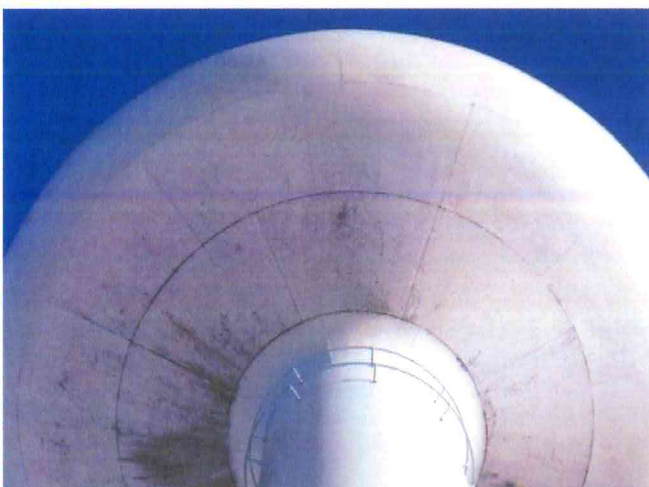
11 *Exterior Wall & Bowl Surfaces Found With Nearly Expired Chalky Coating, Chips Throughout Lowest 30' Of The Pedestal And Mildew Throughout The Underside Of The Bowl*

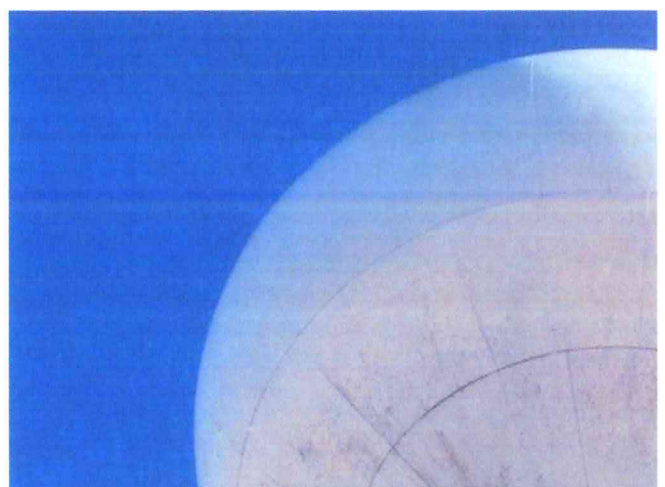
12 *Exterior Wall & Bowl Surfaces Found With Nearly Expired Chalky Coating, Chips Throughout Lowest 30' Of The Pedestal And Mildew Throughout The Underside Of The Bowl*

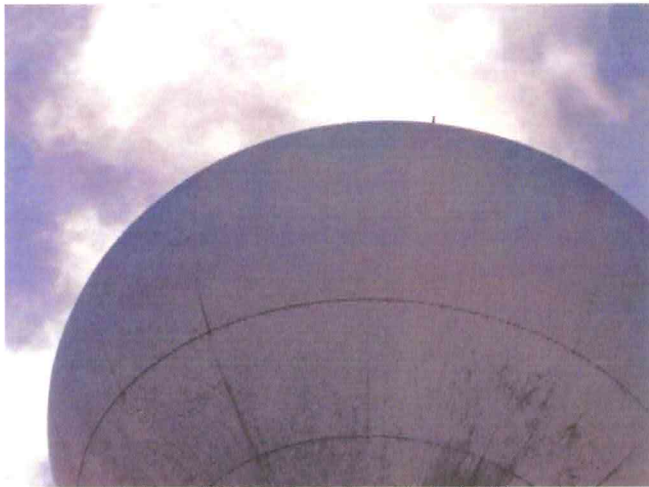
13 *Exterior Wall & Bowl Surfaces Found With Nearly Expired Chalky Coating, Chips Throughout Lowest 30' Of The Pedestal And Mildew Throughout The Underside Of The Bowl*

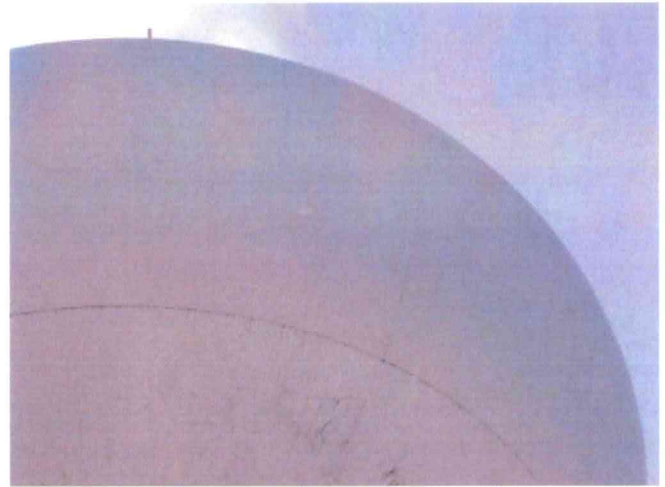
14 *Exterior Wall & Bowl Surfaces Found With Nearly Expired Chalky Coating, Chips Throughout Lowest 30' Of The Pedestal And Mildew Throughout The Underside Of The Bowl*

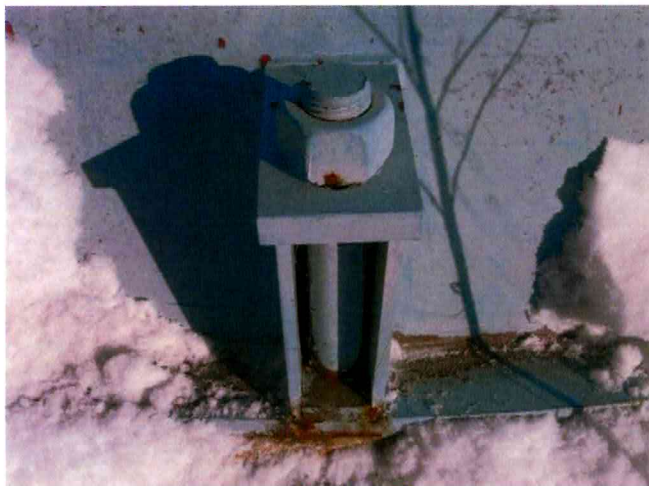
Each bolt was found sound and having a nut properly secured in place while the protective coating applied to all nut, bolt and chair surfaces was found with poor adhesion value causing metal exposure and mild surface corrosion, yet no metal fatigue was apparent.

15 *One Of Fourteen Anchor Bolts Having Metal Exposure And Surface Corrosion*

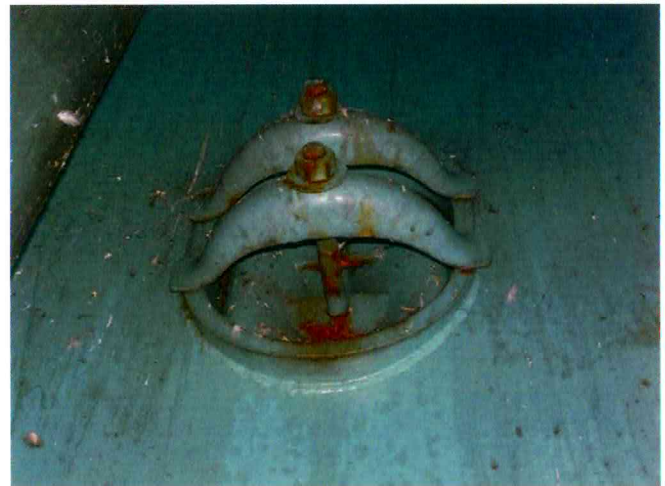
The protective coating applied to this manway shows decline in film thickness (near expiration) causing blotch rusting to show through the coating, and with mild surface corrosion on all hardware.

16 *Manway Having Expired Coating And Blotch Rusting With Surface Corrosion On All Hardware*

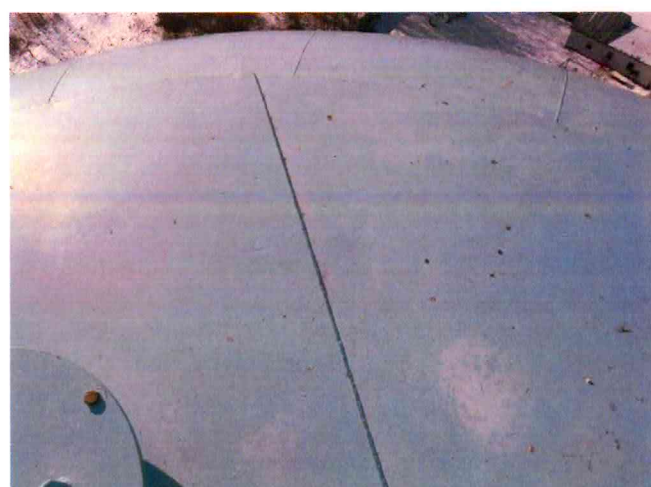
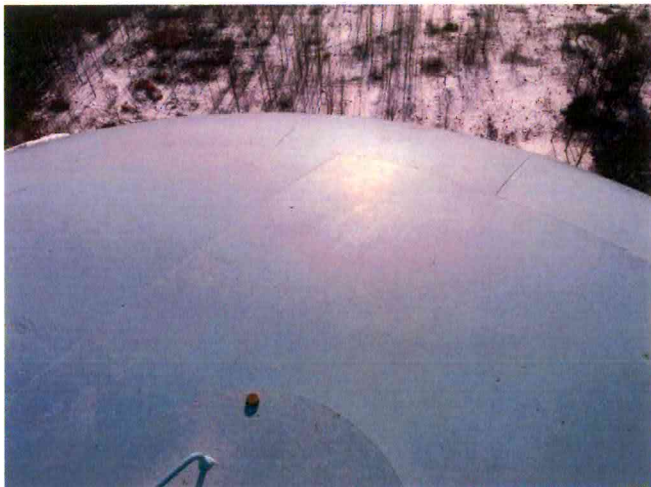
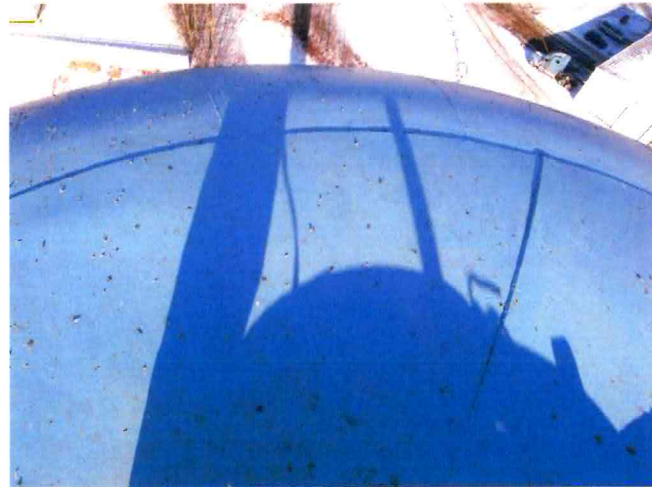
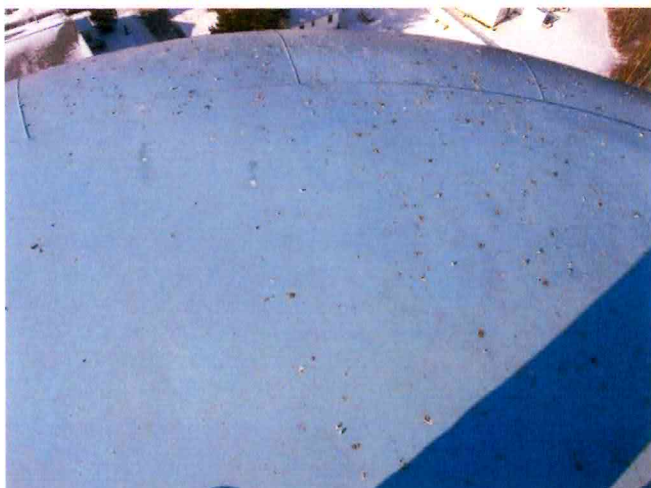
The protective coating applied to these roof dome surfaces shows decline in film thickness caused by weathering and near expiration. This condition has caused the coating to become chalky throughout all surfaces.

The protective coating applied to these roof panels and welds was found with reduced film thickness, caused by weathering and near expiration, resulting in the coating becoming chalky.

24 *Roof Panels Found With Nearly Expired Chalky Coating*

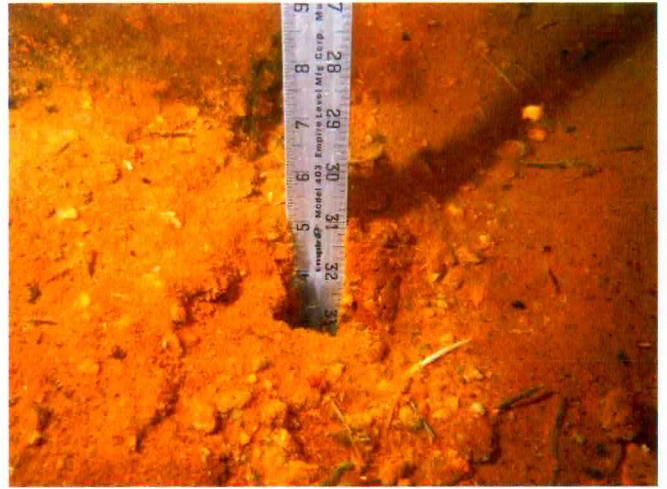
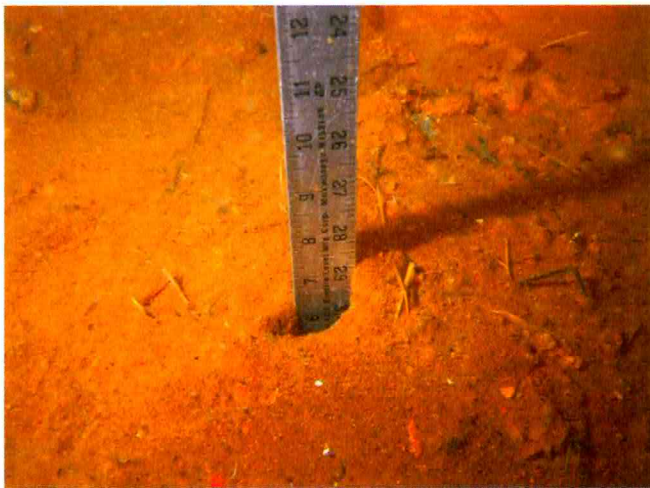
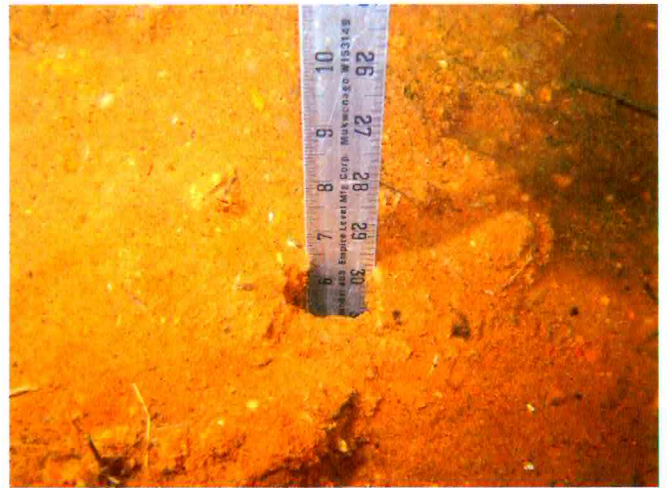
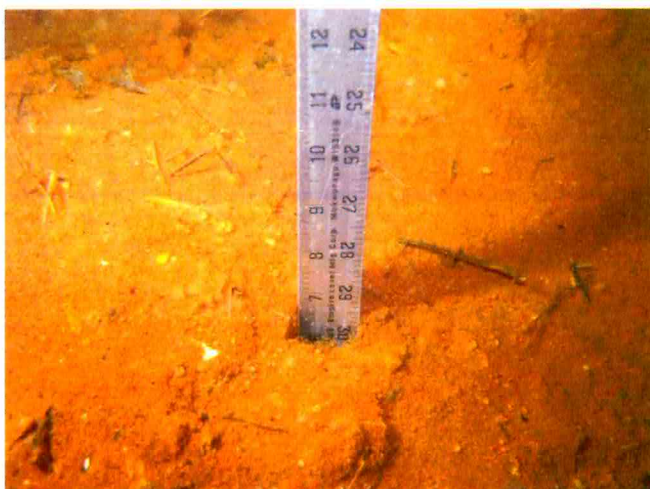
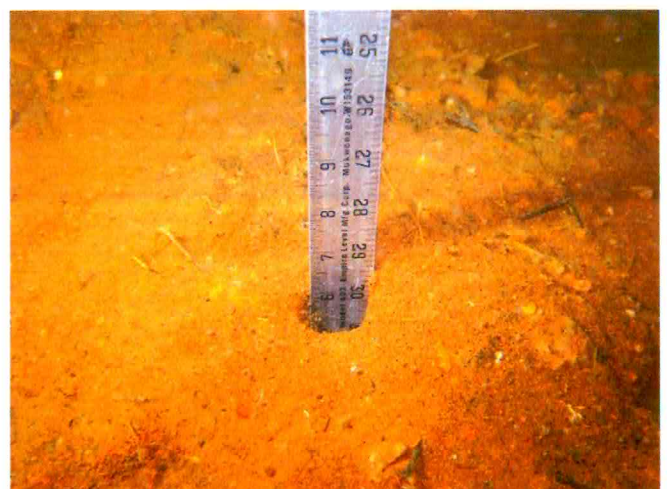
A uniform layer of accumulated precipitate was found on all floor surfaces averaging 6" in depth.

32 *Layer Of Precipitate*

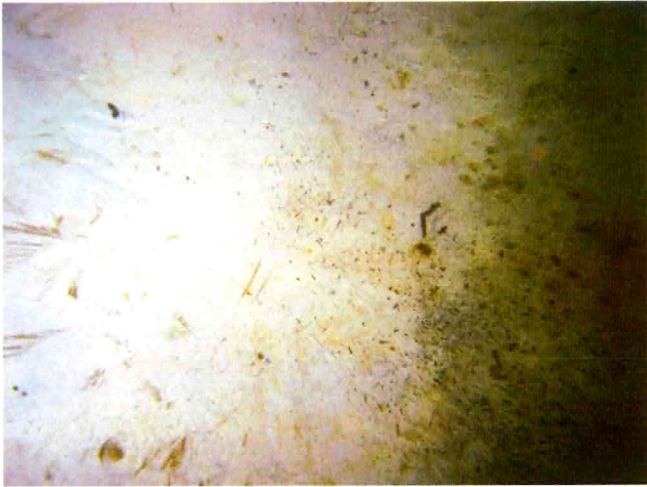
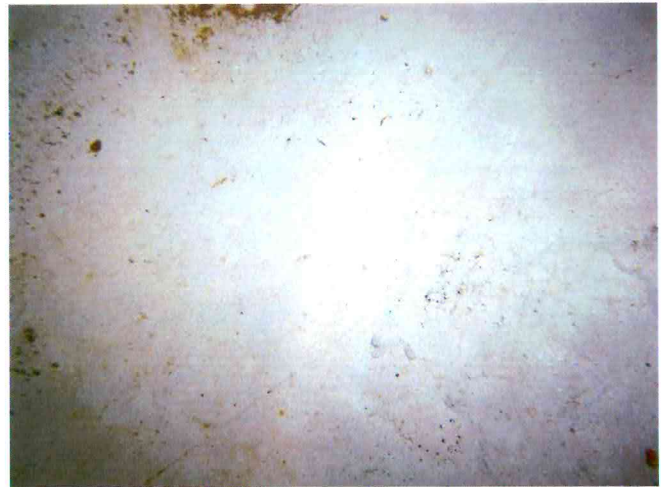
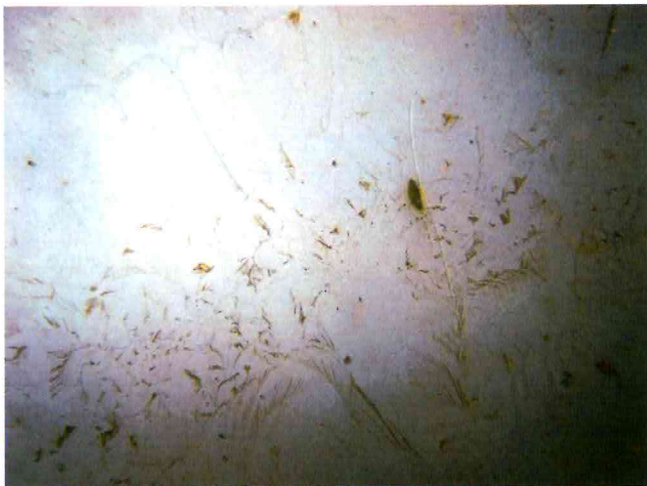
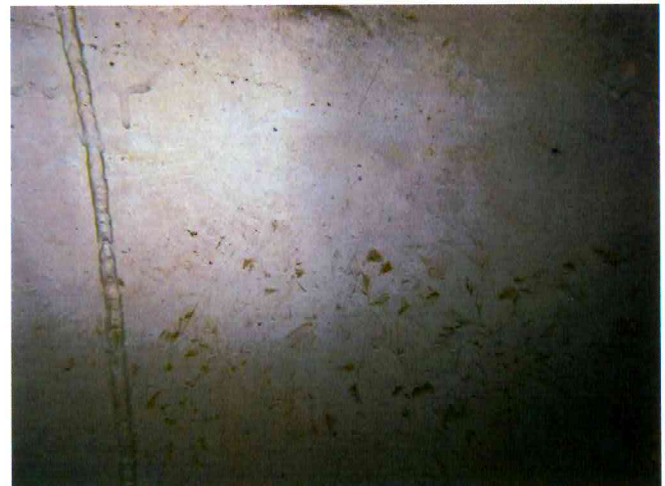
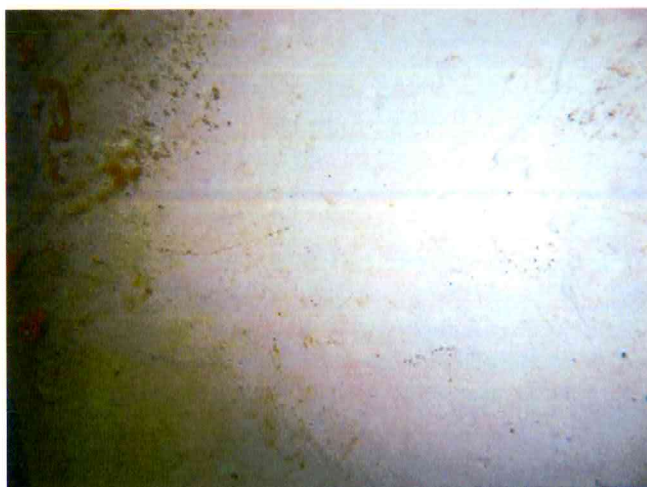
After removing all accumulated precipitate, these steel floor panel and welded surfaces were inspected and found appearing sound while coating failure exposes the underlying steel throughout these surfaces.

The protective coating applied to the floor has failed due to adhesion loss, resulting in coating blisters throughout approximately 10% of all panels and welds.

Approximately 20% of these coating blisters have ruptured, resulting in exposure and causing corrosion of the exposed steel. Mild, non-measurable pitting of the steel also was found within these exposed areas.

37 *Floor Surfaces Found With Coating Failure, Exposed Steel, Moderate Surface Corrosion And Pitting After Cleaning*

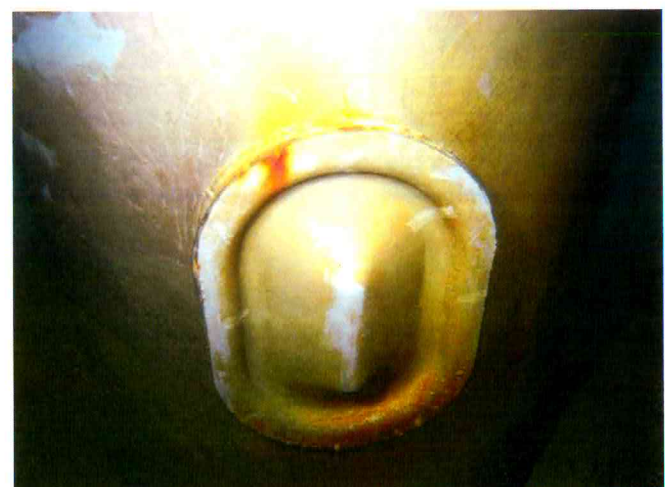
Numerous coating blisters have ruptured throughout all surfaces of this manway, resulting in exposure of the steel and moderate surface corrosion due to adhesion loss.

42 *Manway Found With Coating Failure, Exposed Steel And Moderate Surface Corrosion*

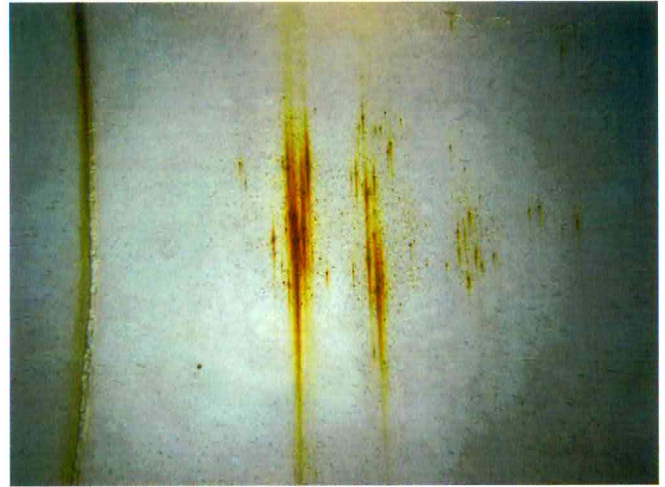
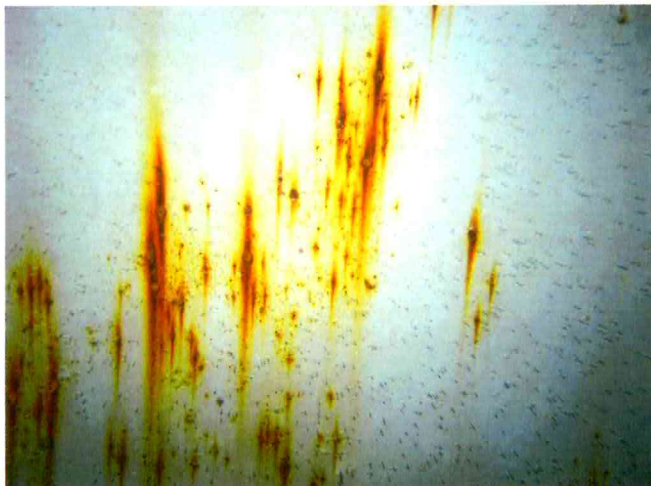
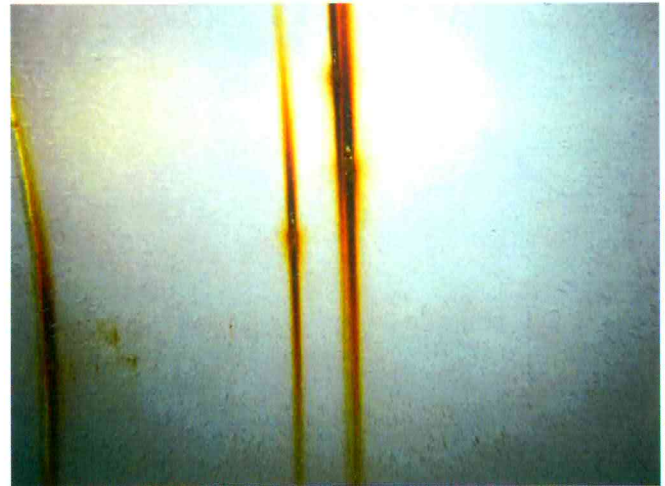
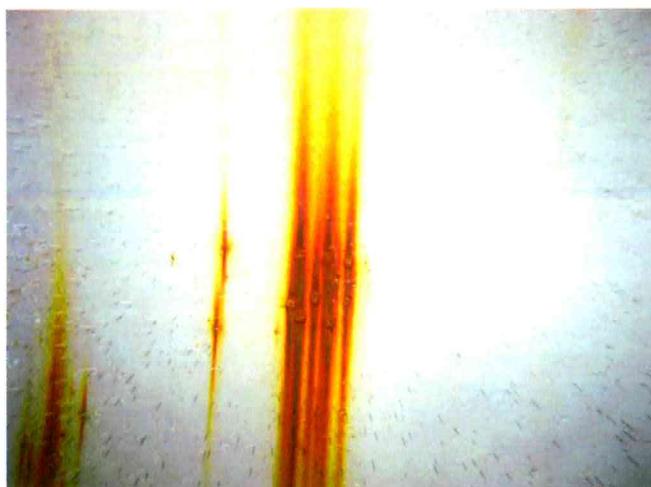
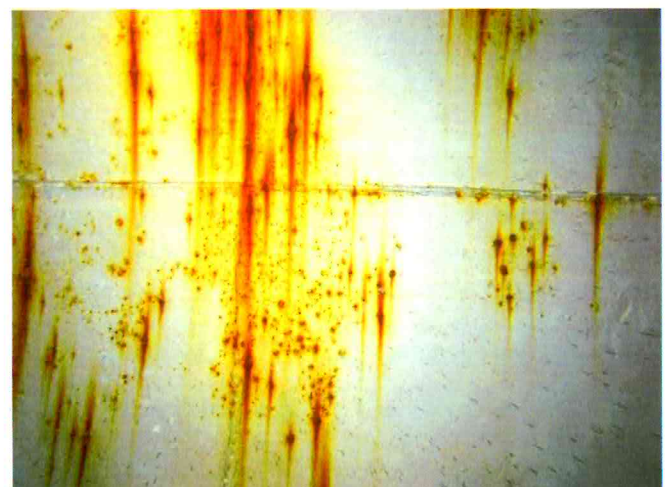
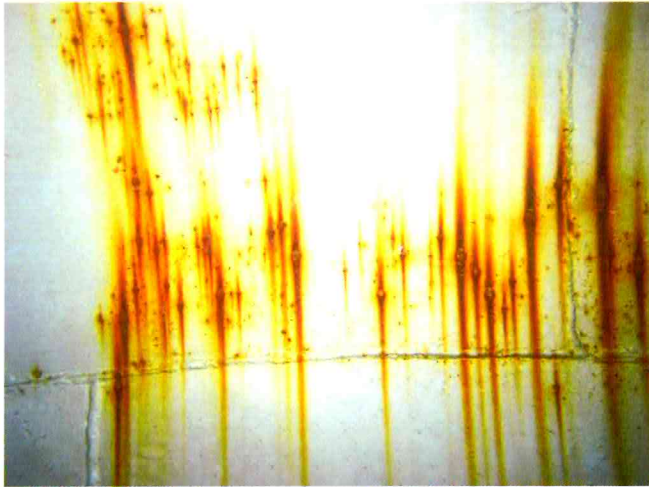
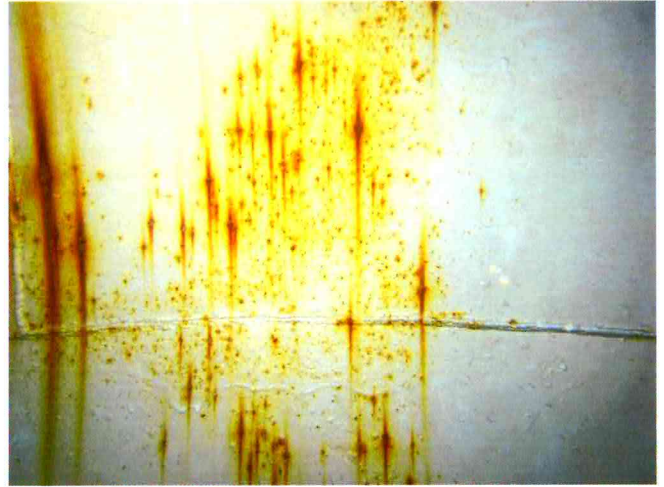
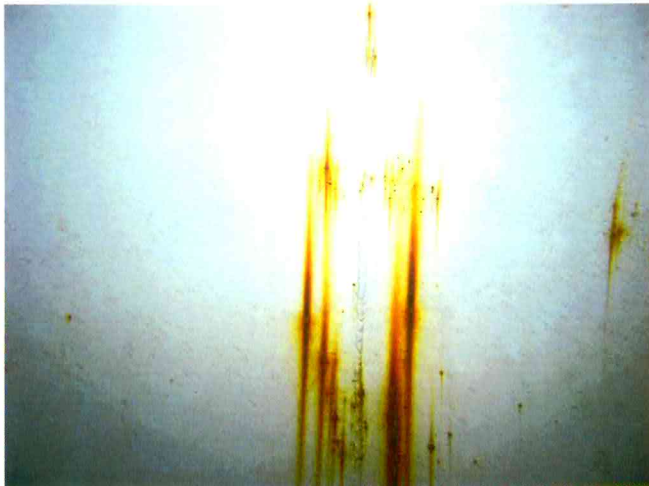
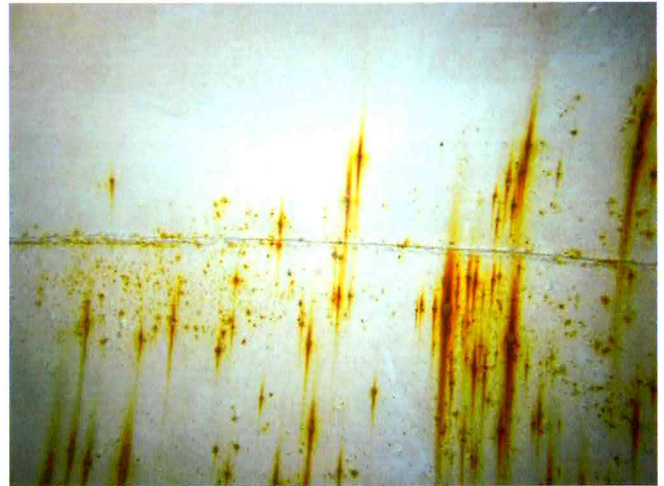
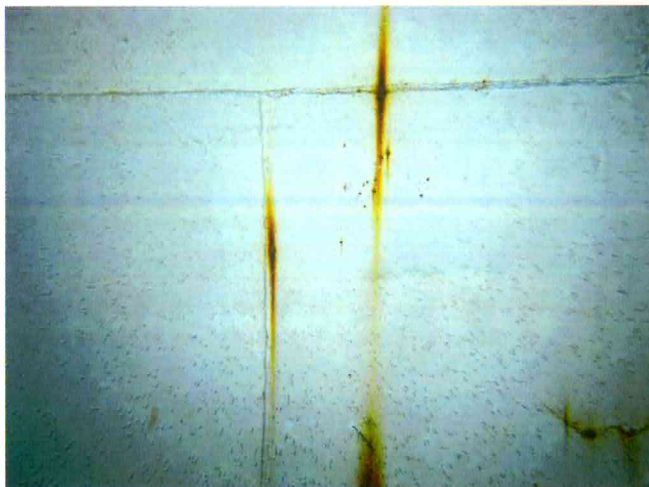
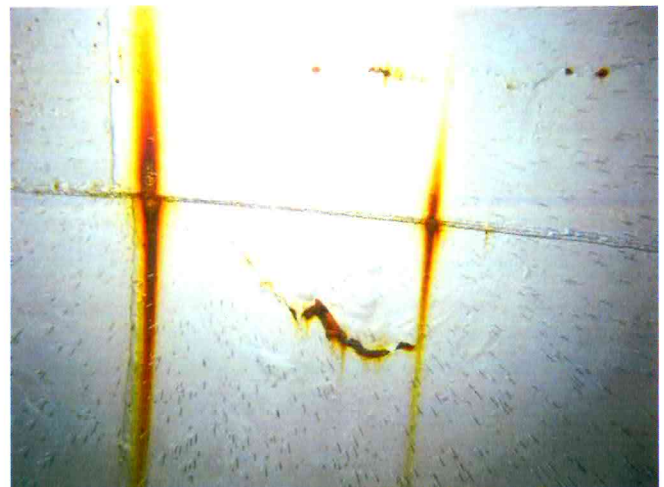
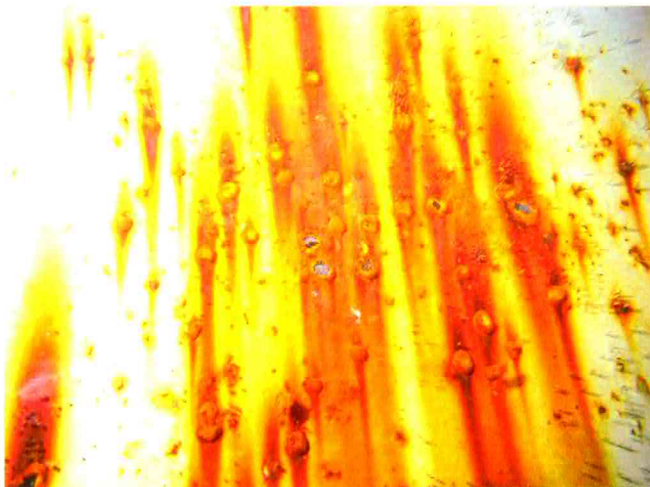
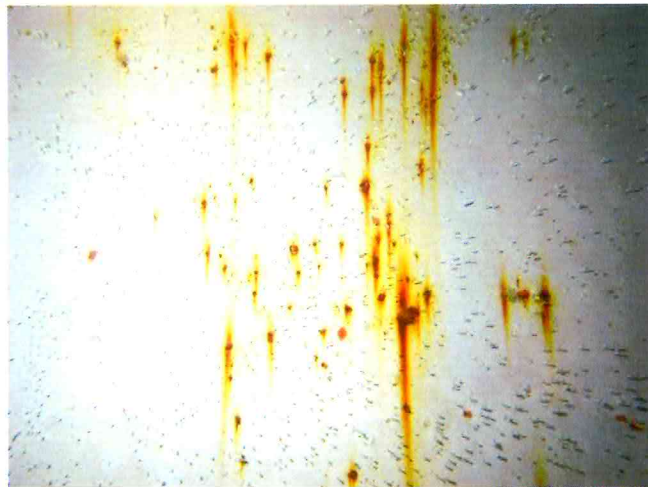
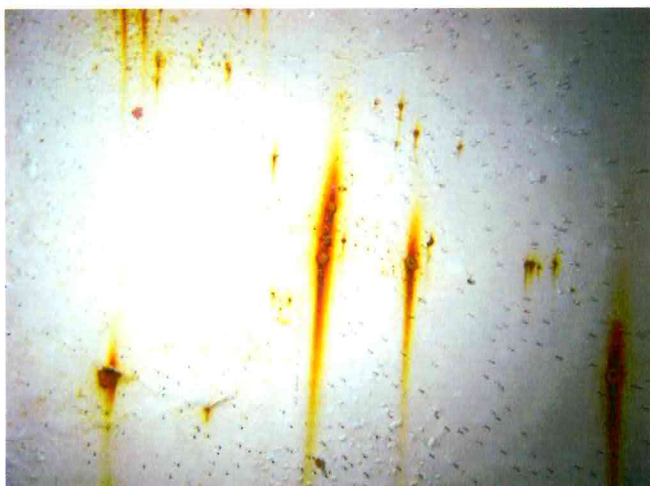
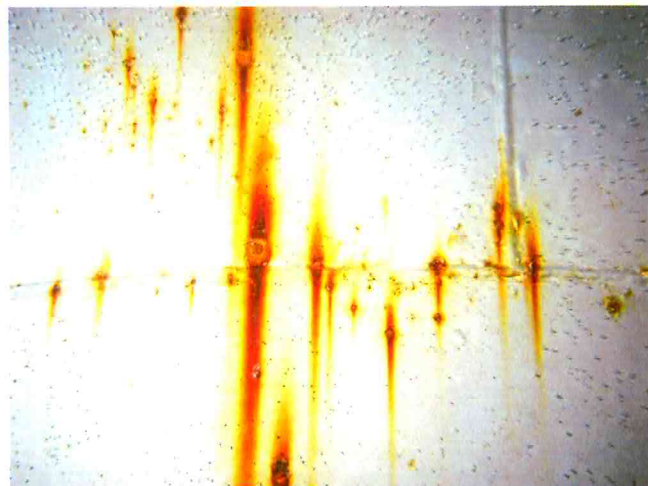
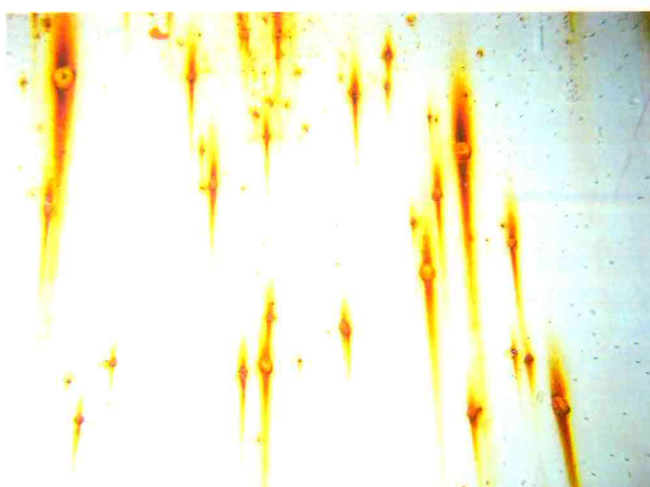
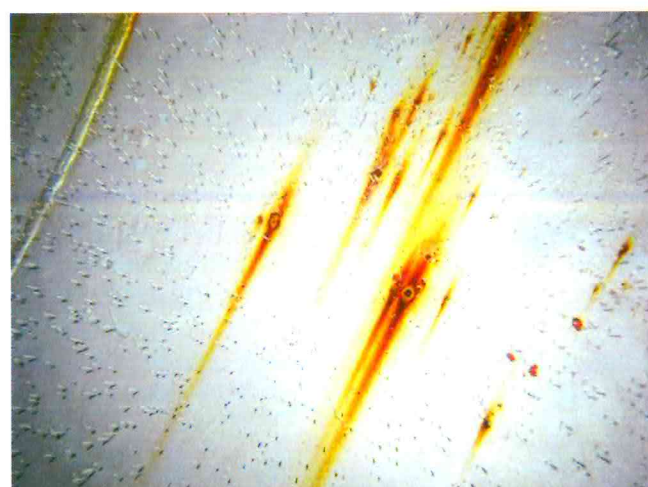
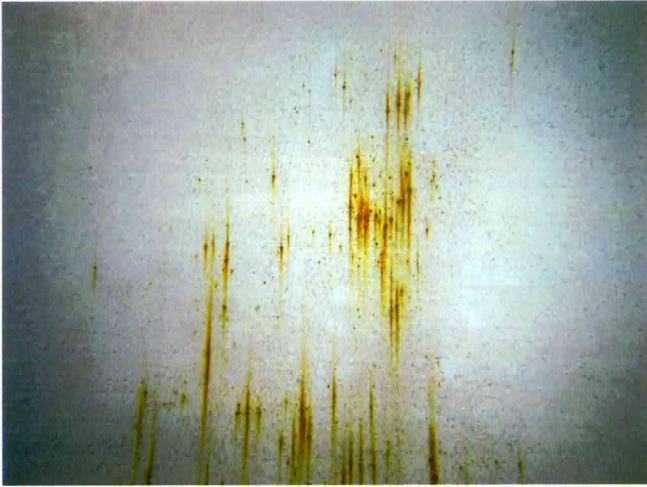
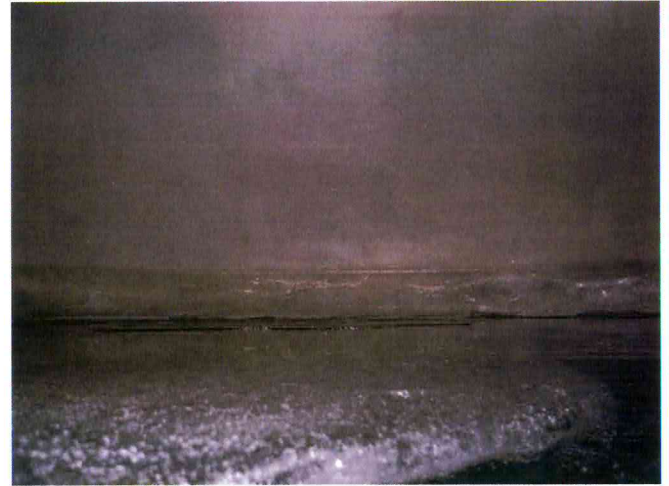
These interior wall panel and weld surfaces appeared sound while the protective coating applied to these wall panel and weld surfaces has failed (expired) throughout all elevations of the tank.

Coating blisters, found throughout approximately 45% of all wall panels and welds, exist due to adhesion loss.

Approximately 30% of these coating blisters have ruptured, exposing the underlying steel and cause moderate surface corrosion throughout causing moderate surface corrosion. Mild, non-measurable pitting of the steel also was found within these exposed areas.

44 *Interior Wall Panels Found With Coating Failure, Exposed Steel, Moderate Surface Corrosion And Pitting*

It is the opinion of Underwater Solutions Inc. that although this welded steel water storage tank appears mostly sound and without leakage at this time, rehabilitation is required within the near future to preserve the integrity of the steel, as the interior coating system has failed (expired).

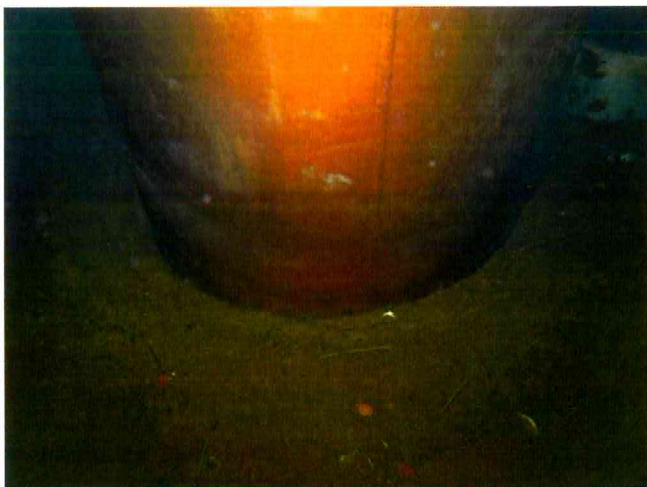
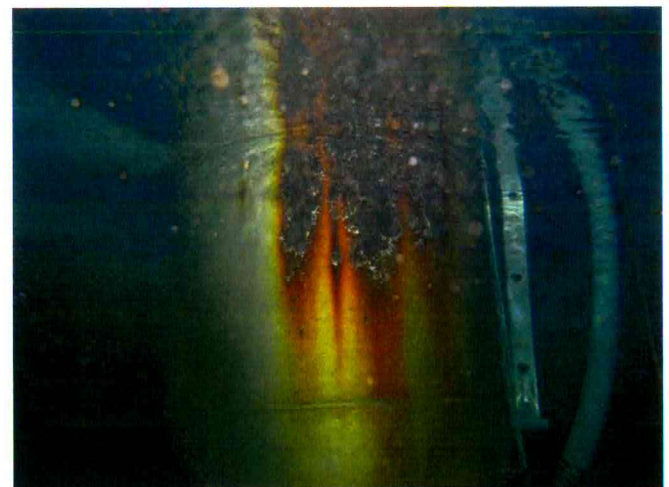
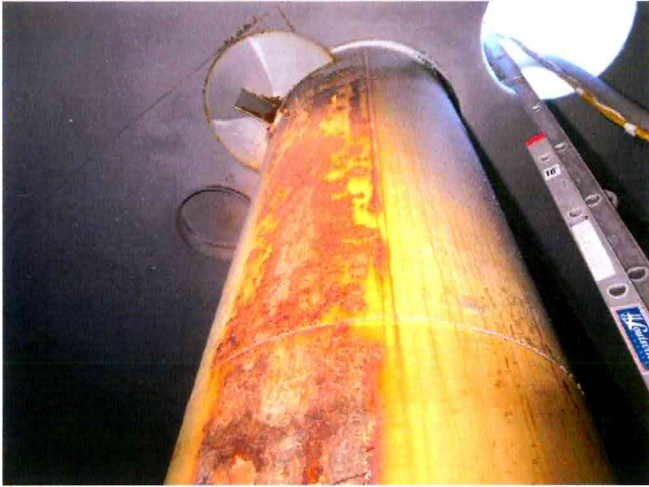
The 40" outside diameter center riser column appeared sound while the protective coating applied to these surfaces has failed throughout all elevations of the column.

Coating blisters, found throughout approximately 50% of all column surfaces, exist due to adhesion loss.

Approximately 80% of these coating blisters have ruptured, exposing the underlying steel and cause moderate surface corrosion at this time.

65 *Center Riser Column Found With Coating Failure, Exposed Steel And Moderate Surface Corrosion*

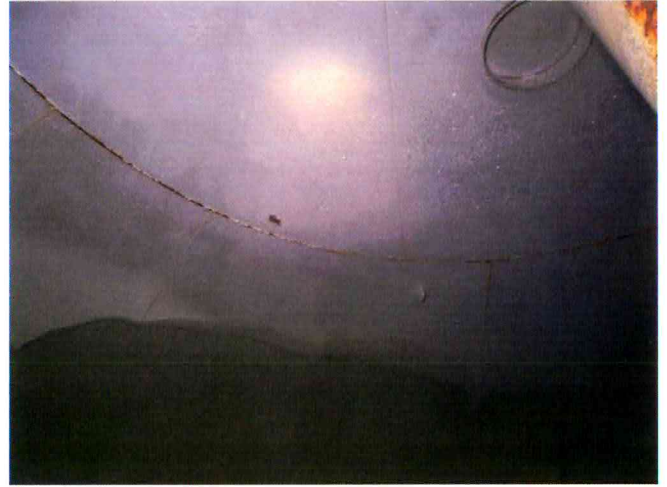
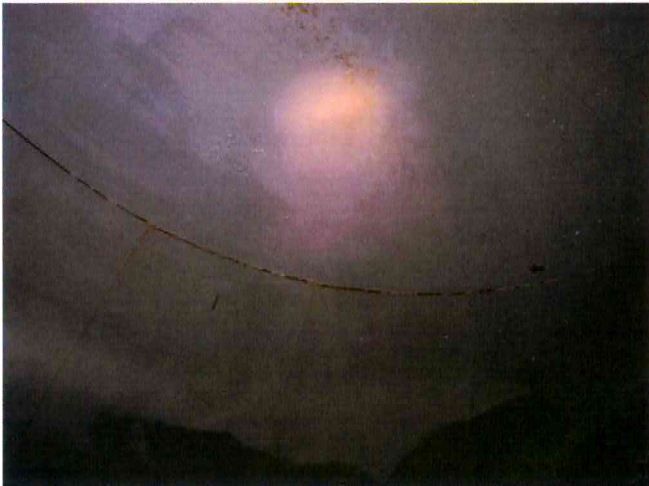
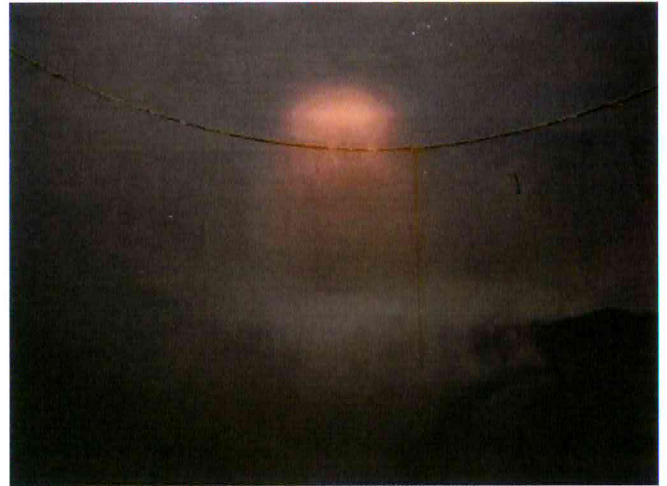
The protective coating applied to these overhead surfaces was found with reduced film thickness, (expiration) causing blotch rusting to show through the coating throughout approximately 10% of these surfaces.

68 *Overhead Panels Found With Coating Failure And Blotch Rusting*
