Addendum No. 1

Re: Dells Pond Outlet Dam Improvements Project
Town of Littleton

From: DuBois & King, Inc.
Charles Johnston, P.E.
6 Green Tree Drive
South Burlington, Vermont 05403
(802) 878-7661

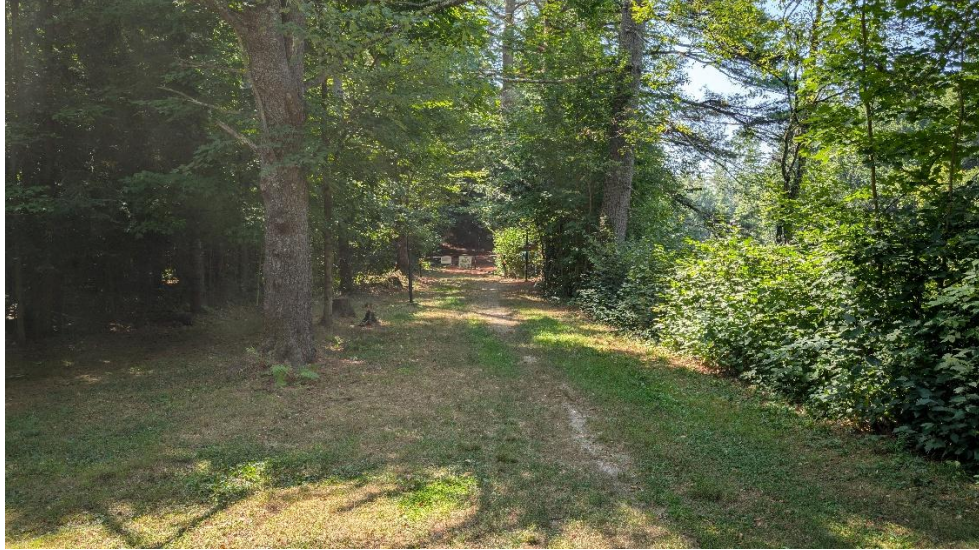
Access from NH-18 through parking lot

The site can be accessed in two ways. The primary access is from Dells Road on the left abutment of the dam (looking downstream). The secondary access is from NH-18 into the Dells Pond Park parking area and via a trail. There are gates that restrict vehicular access. The park will be closed for construction; however, the Town is looking to open the park as soon as possible, which is why a schedule is being requested.

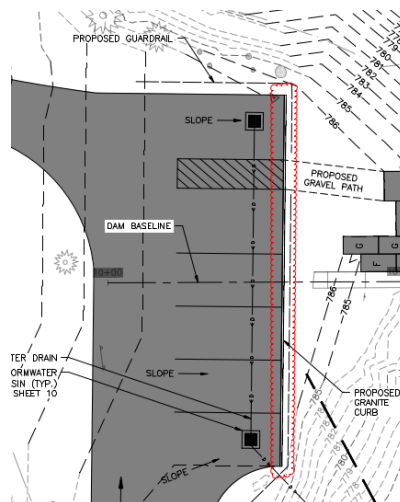
The granite curbing is only intended along the front of the parking to prevent stormwater from flowing on dam crest and down slopes. See Plan Sheet 7.

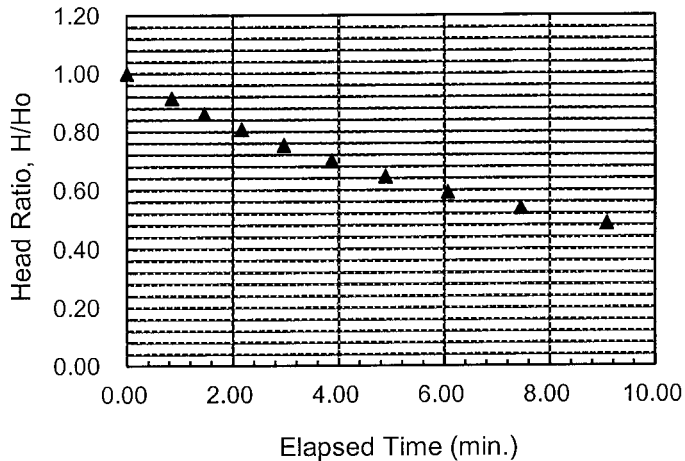
P-1

TIME (hr.min.sec)	ELAPSED TIME (min)	DEPTH-RIM TO WATER (feet)	HEAD H (feet)	HEAD RATIO H/Ho	K (cm/sec)	K (feet/min)
10:00:00 AM	0.00	0.00	18.70	1.00		
10:00:51 AM	0.85	1.60	17.10	0.91	9.2E-04	1.8E-03
10:01:28 AM	1.47	2.60	16.10	0.86	8.6E-04	1.7E-03
10:02:10 AM	2.17	3.60	15.10	0.81	8.0E-04	1.6E-03
10:02:58 AM	2.97	4.60	14.10	0.75	7.5E-04	1.5E-03
10:03:52 AM	3.87	5.60	13.10	0.70	7.2E-04	1.4E-03
10:04:53 AM	4.88	6.60	12.10	0.65	6.8E-04	1.3E-03
10:06:04 AM	6.07	7.60	11.10	0.59	6.4E-04	1.3E-03
10:07:27 AM	7.45	8.60	10.10	0.54	6.0E-04	1.2E-03
10:09:05 AM	9.08	9.60	9.10	0.49	5.6E-04	1.1E-03
Ave. permeability:					7.3E-04	1.4E-03

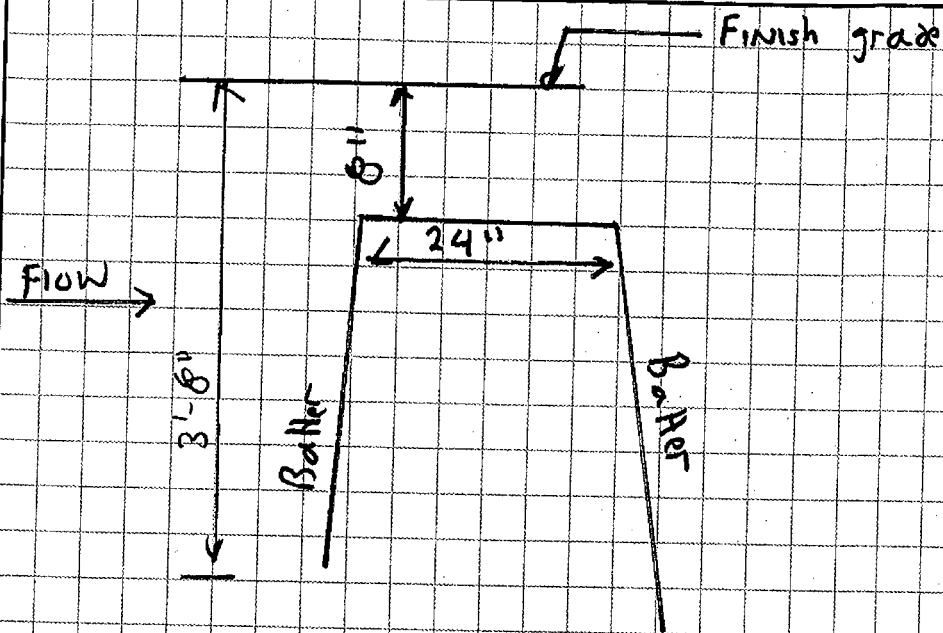
wall @ T.P # 3

NO WALL FOUND
AT Depth of 5' ±

NO wall @ T.P # 2

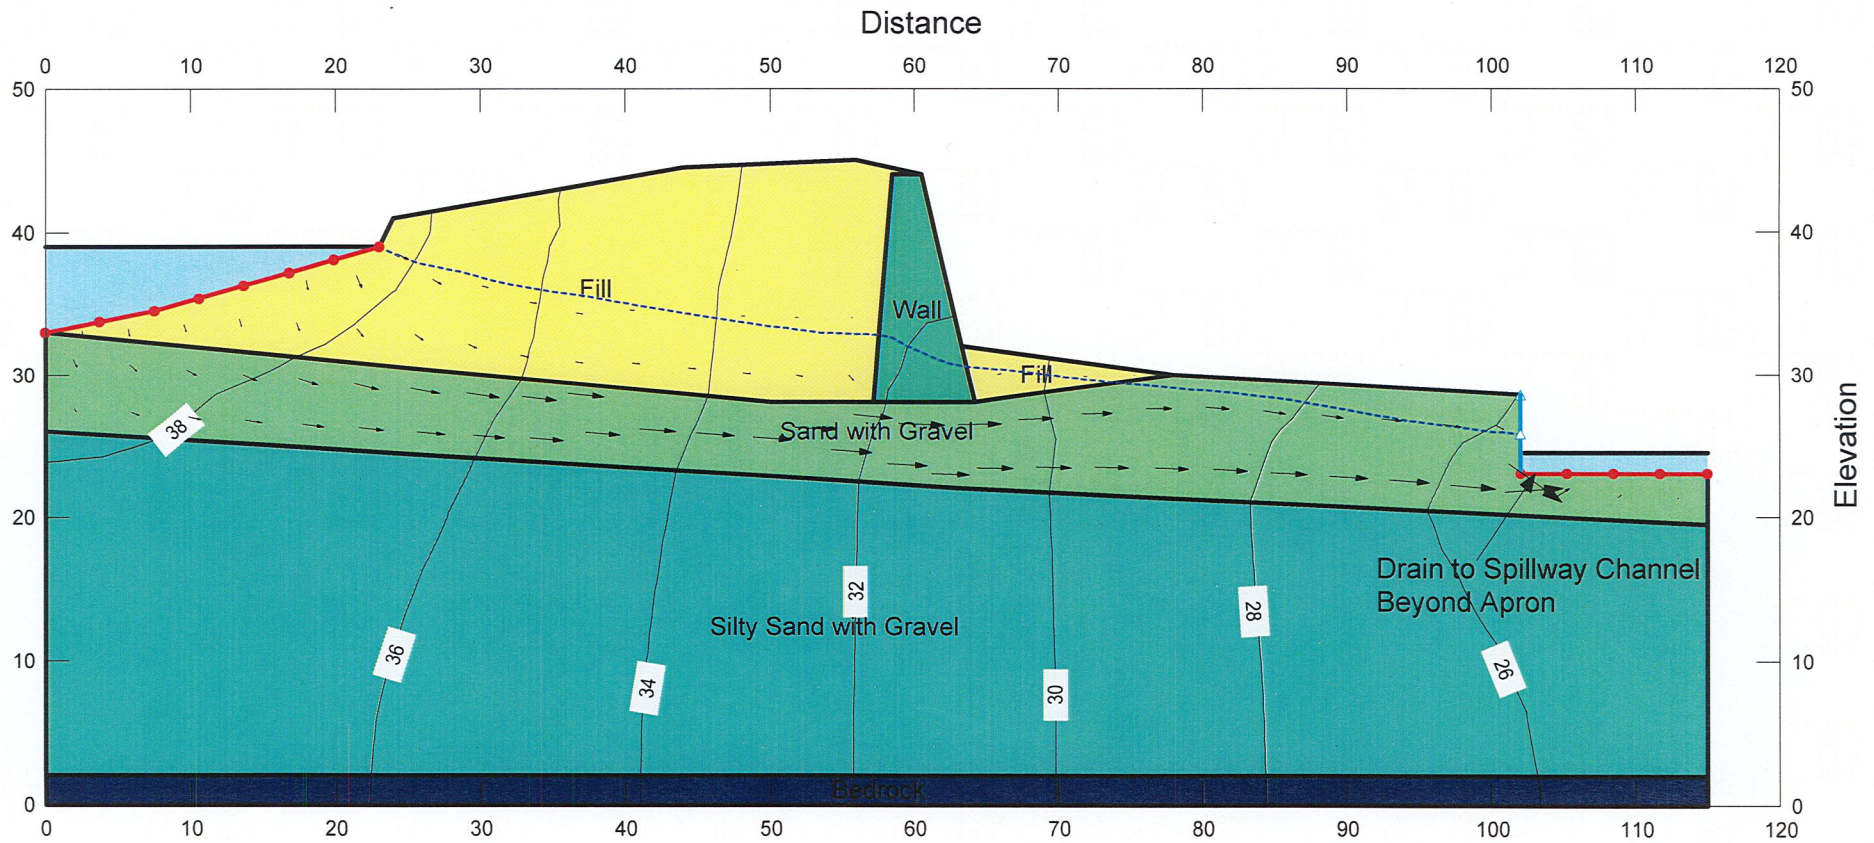
Figure C.1 - Max Embankment Retaining Wall Section
Existing Conditions
Normal Pool

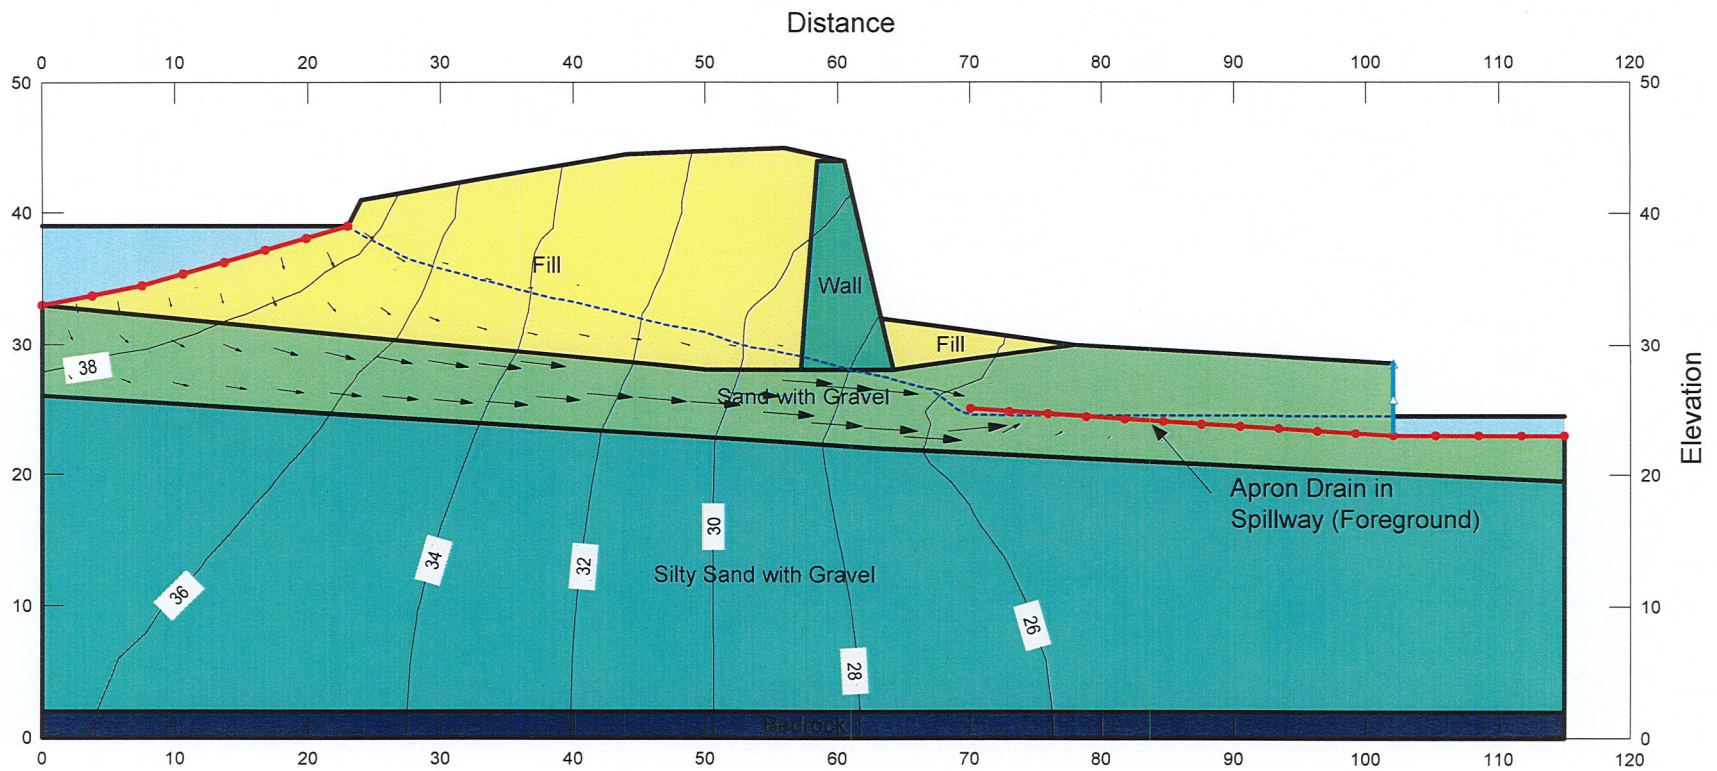
Figure C.2 - Max Embankment Retaining Wall Section
Existing Conditions
Normal Pool
Drain to Apron in Spillway Channel

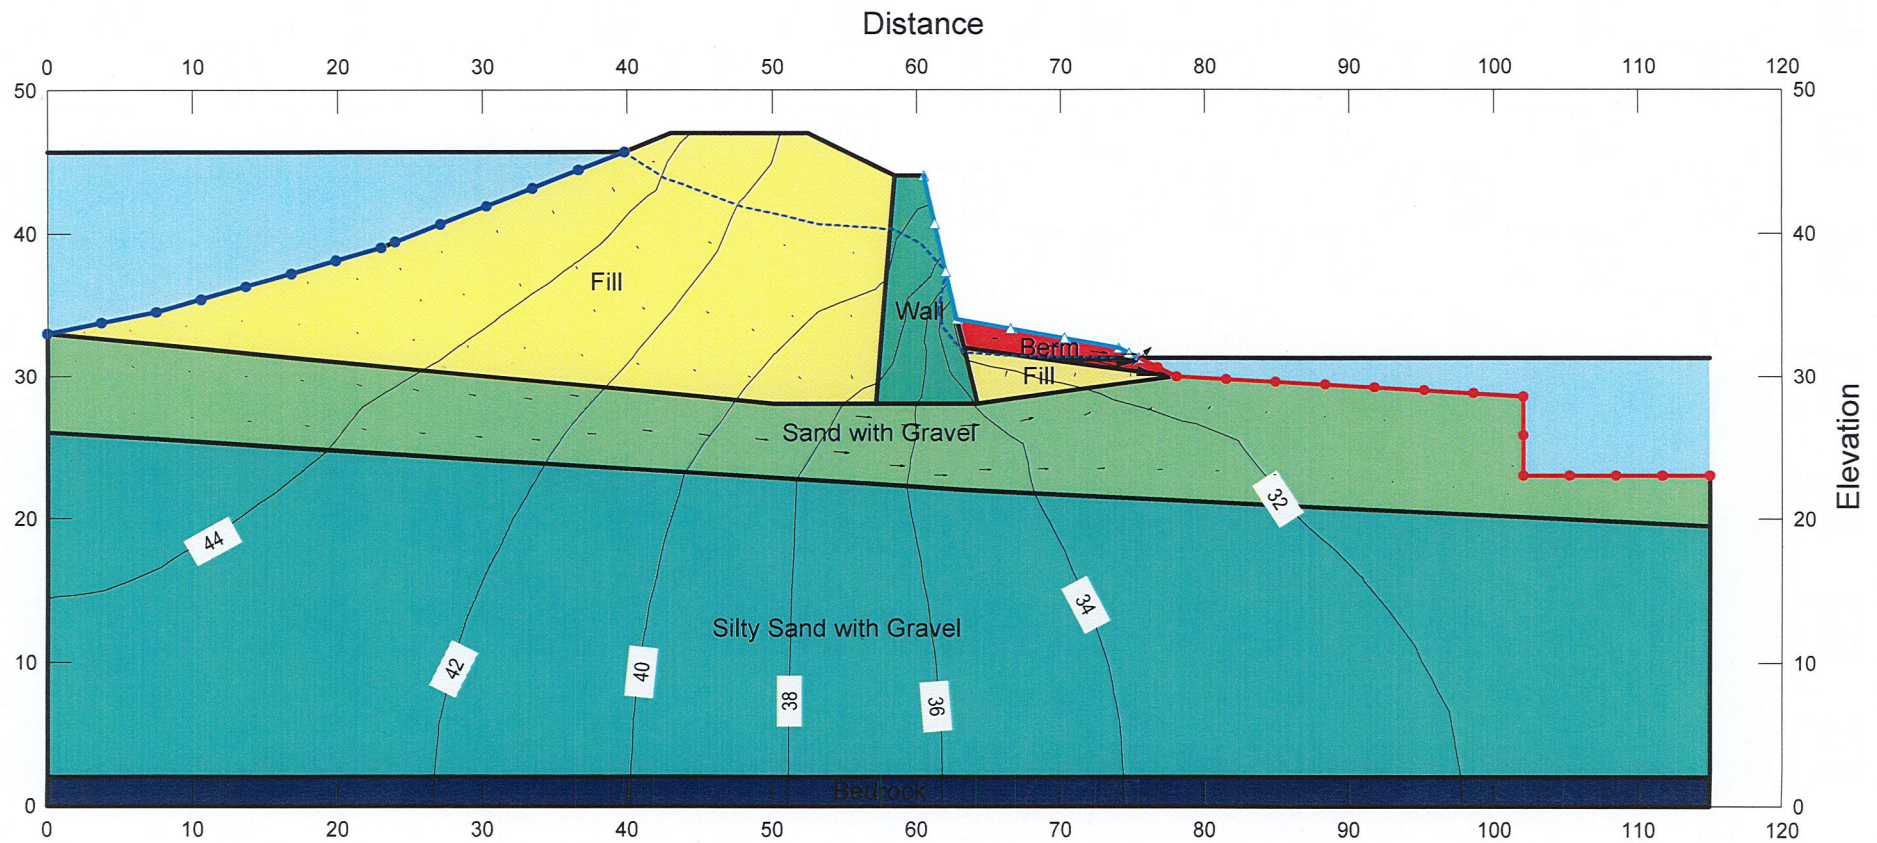
Figure C.3 - Max Embankment Retaining Wall Section
Proposed Conditions with Berm
Design Flood

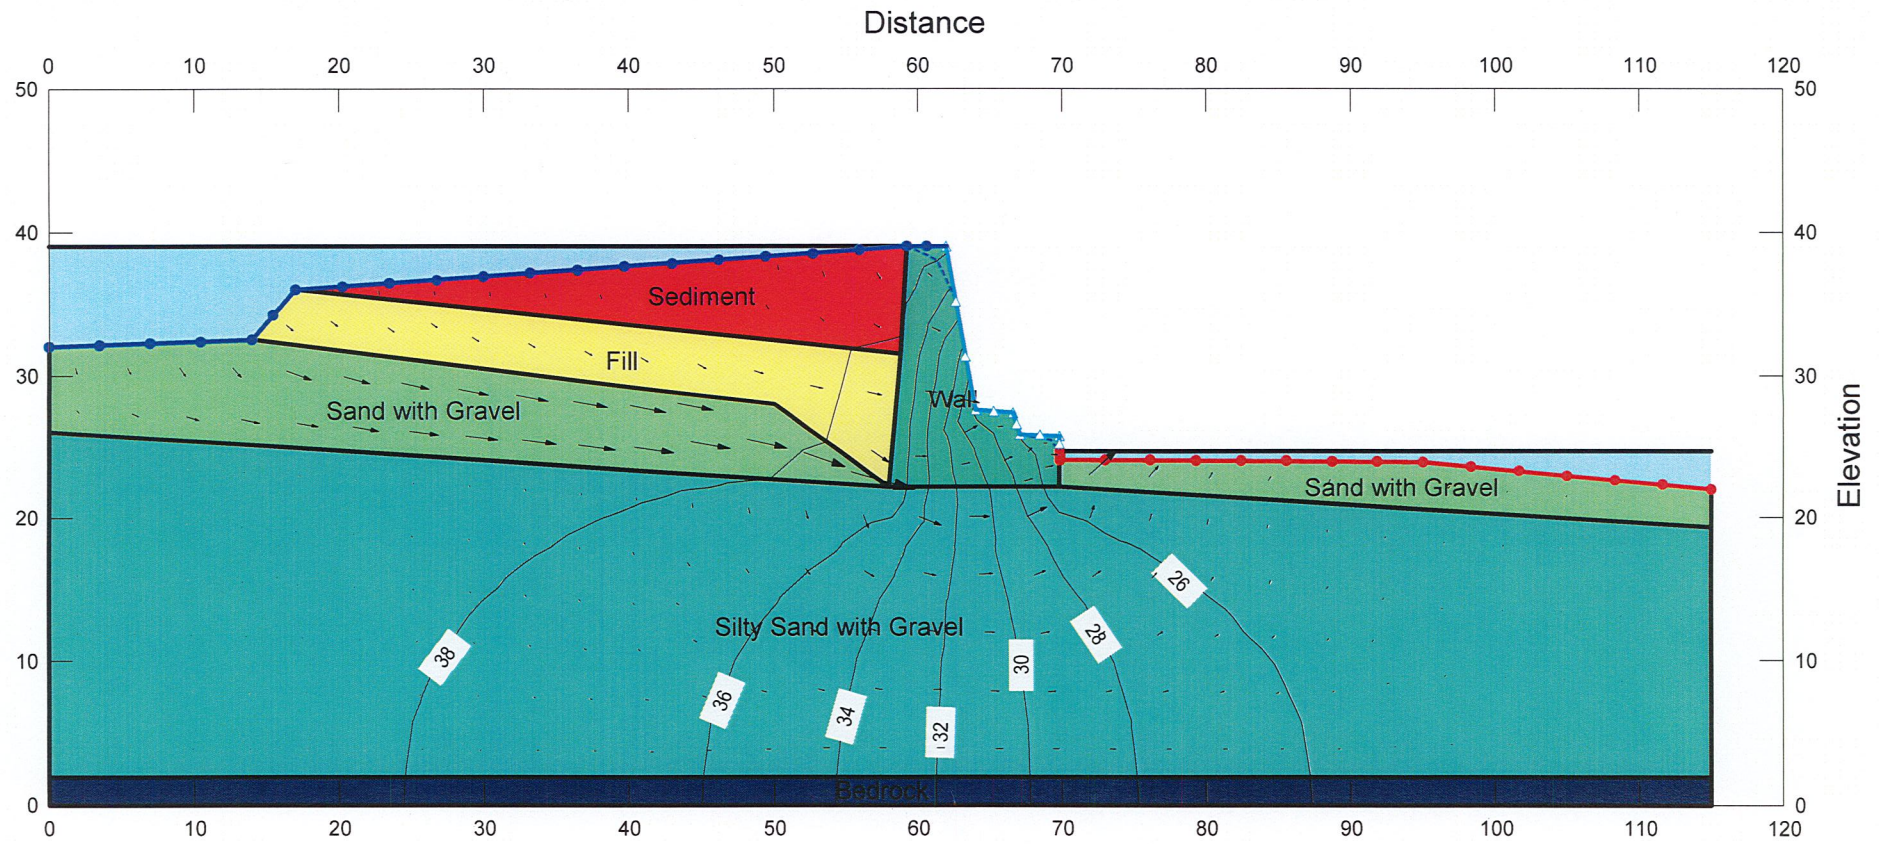
Figure C.4 - Spillway Section
Normal Pool

External (local) stability analyses were conducted for the spillway section shown on Figure 4. The stability of the spillway was analyzed for the normal pool, design flood, and seismic load cases. These analyses apply to both existing and proposed conditions since the proposed raising of the dam does not explicitly include modifications to the spillway. However, as discussed later in this section, modification to the spillway will be necessary to satisfy stability criteria.

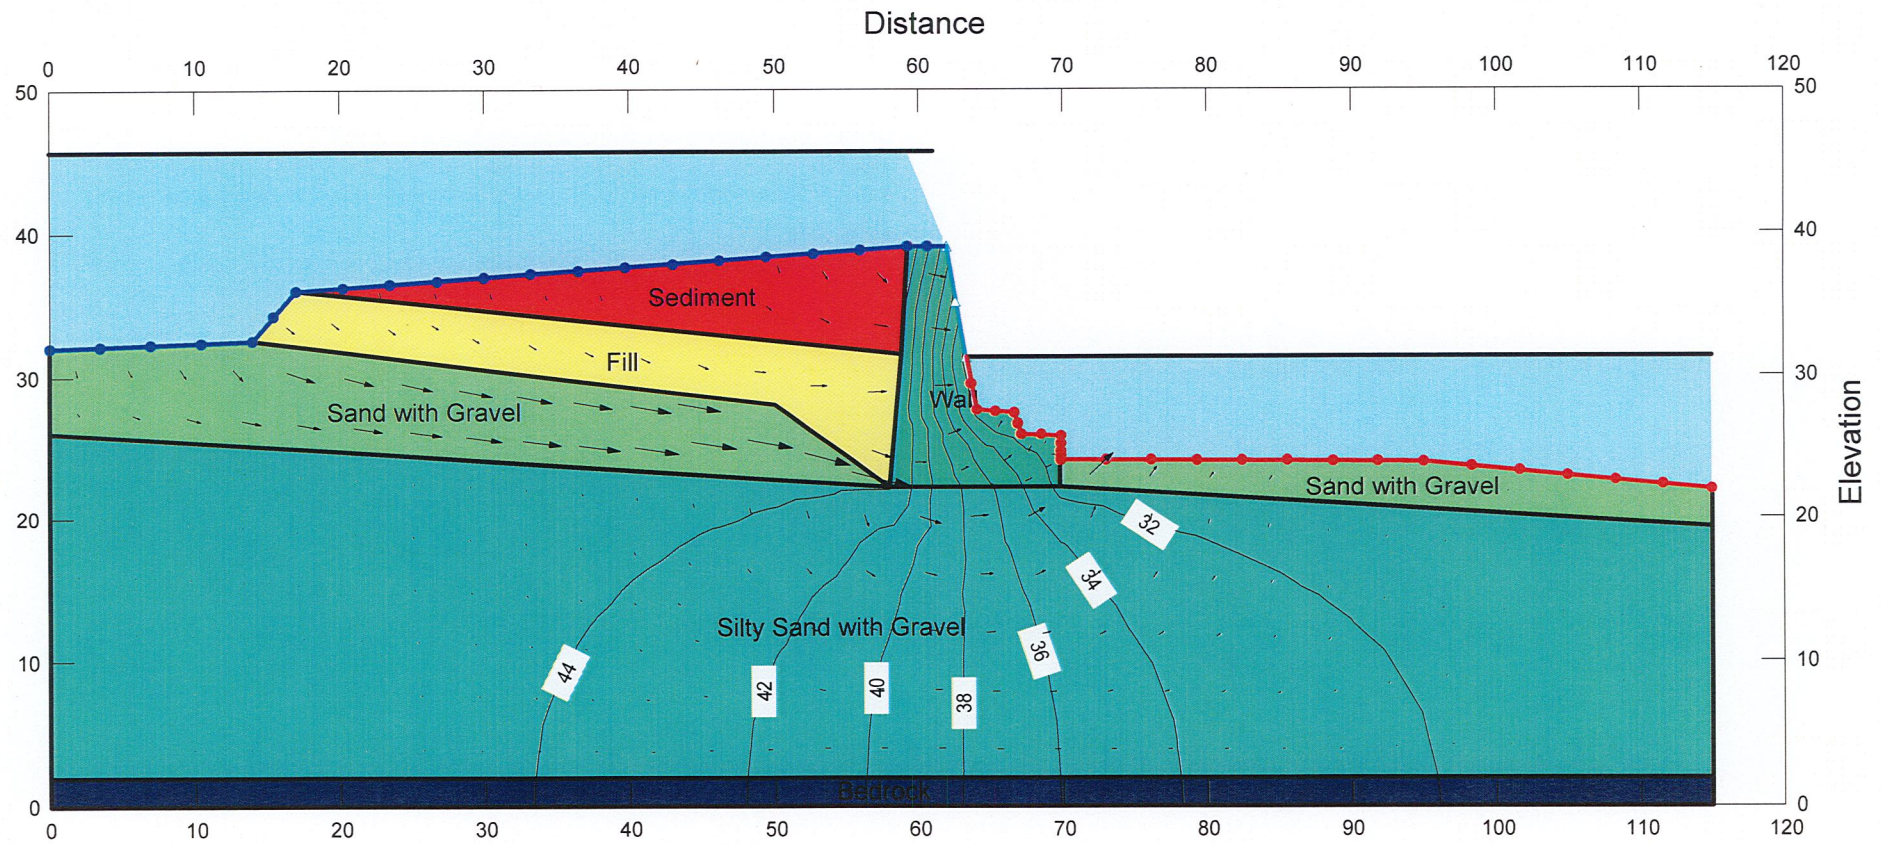
Figure C.5 - Spillway Section
Design Flood

5. The Design Flood Case does not meet the sliding stability criteria for "Unusual Load Condition" ($FS_{min} = 1.3$), but does meet sliding stability criteria for the "Extreme Load Condition" ($FS_{min} = 1.1$). An additional horizontal restraining force of approximately 45 kips would be needed to meet the sliding stability criteria for the "Unusual Load Condition". This could be accomplished by placing a concrete berm with a submerged weight of 4.1 kip per foot of spillway on the upstream or downstream face of the spillway. Soil anchors could also be considered to increase sliding stability.

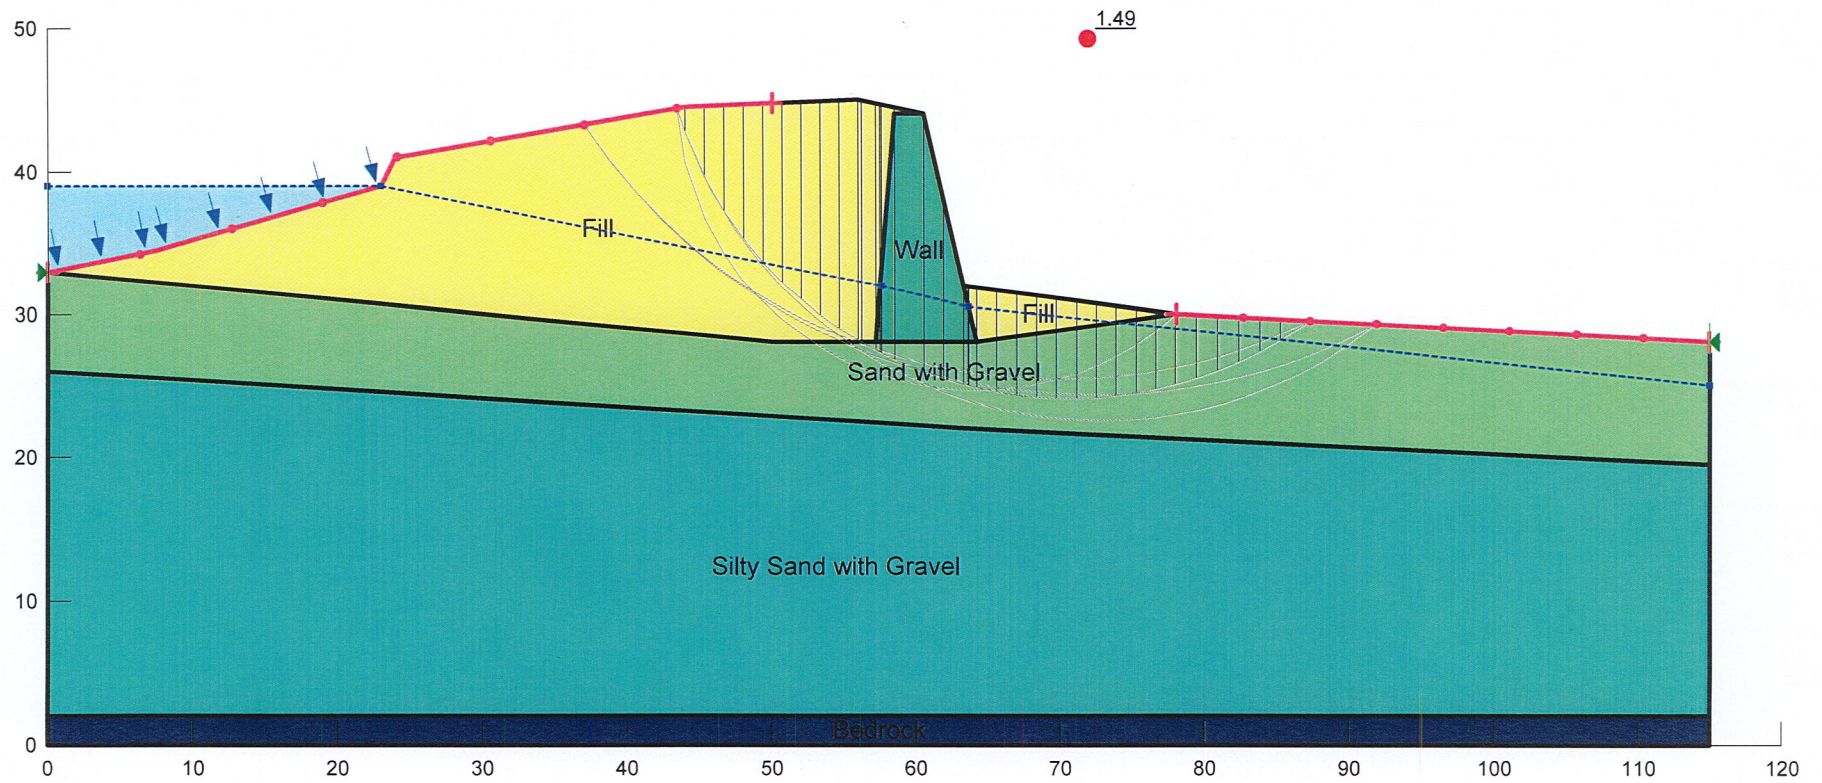
Figure D.1 - Max Embankment Section
Existing Conditions
Normal Pool

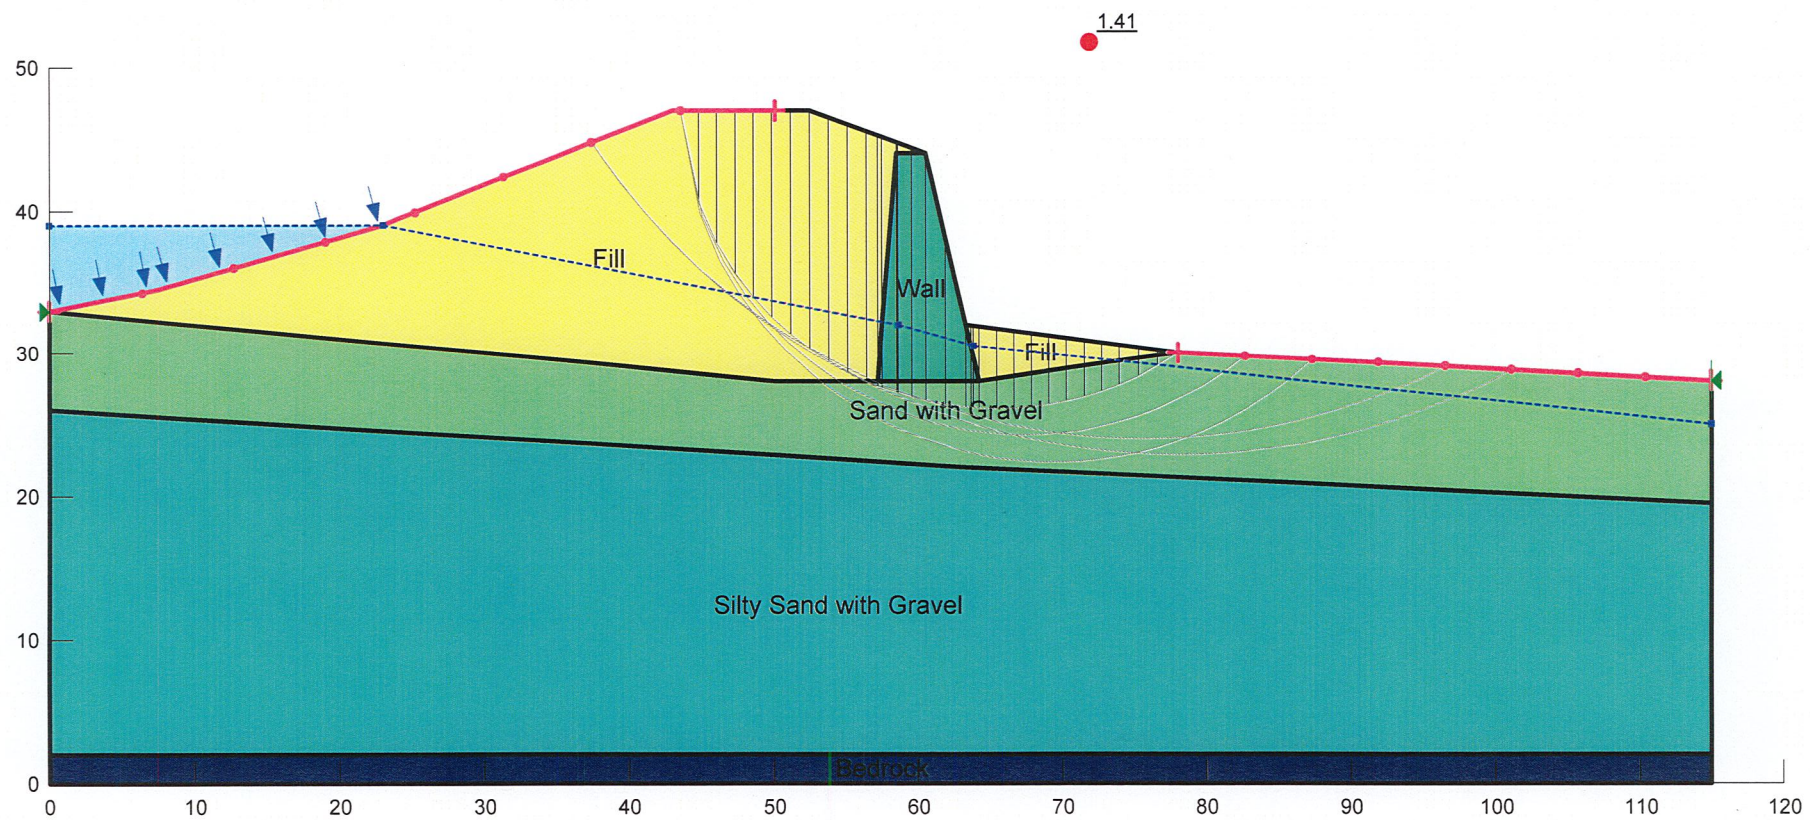
Figure D.2 - Max Embankment Retaining Wall Section
Proposed Conditions
Normal Pool

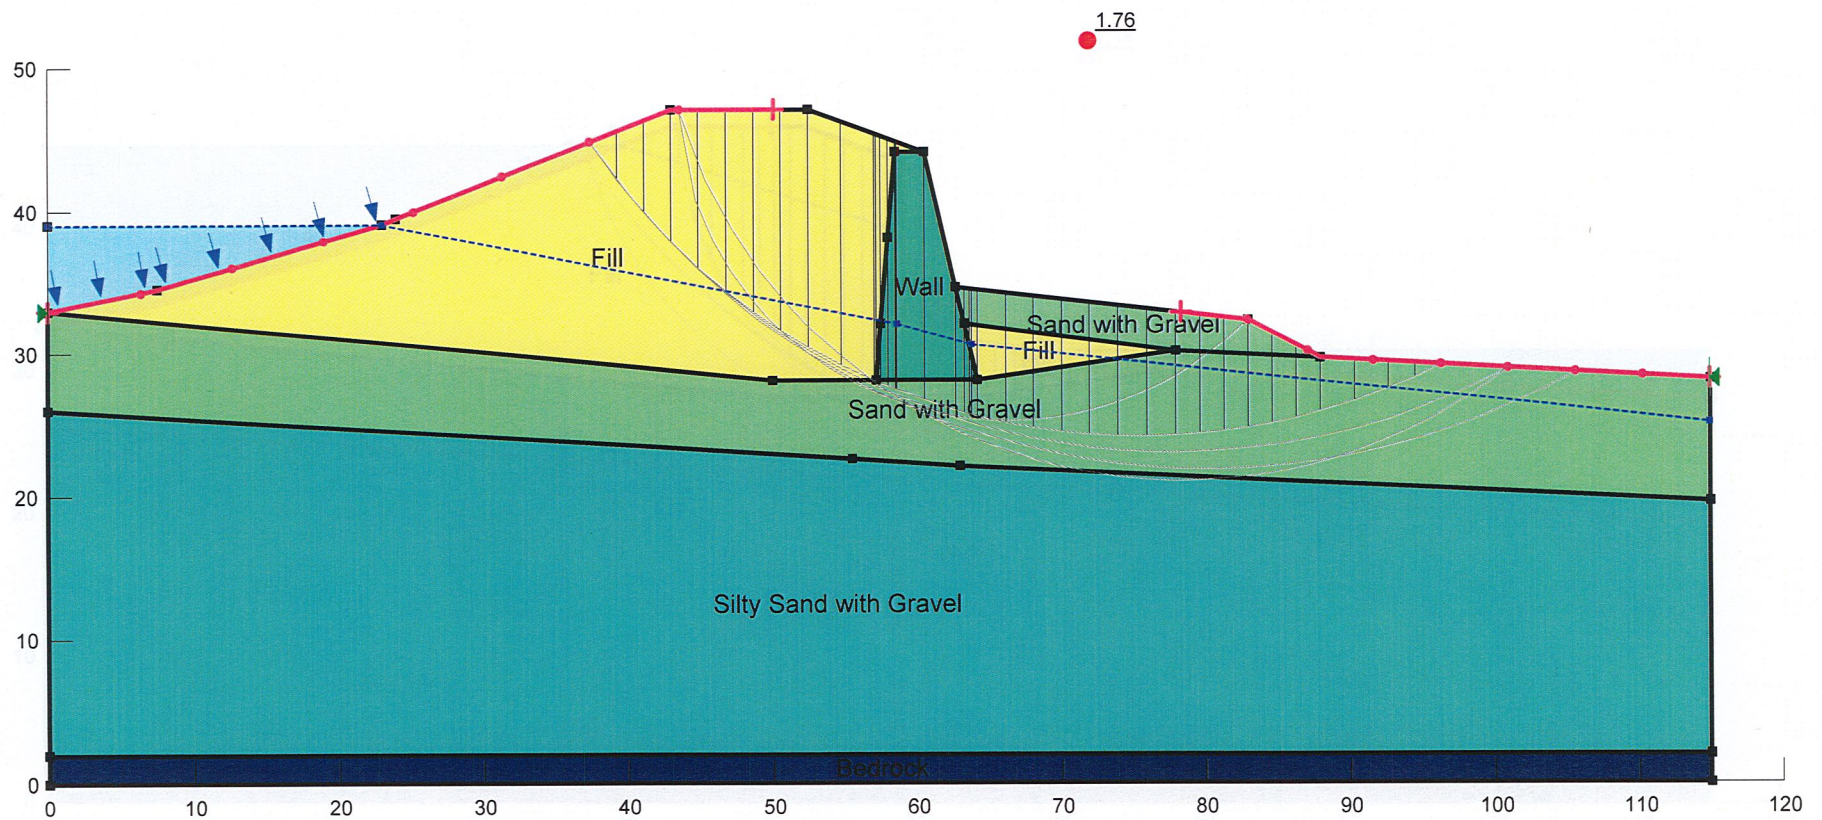
Figure D.3 - Max Embankment Retaining Wall Section
Proposed Conditions with 2.5' x 20' Berm
Normal Pool

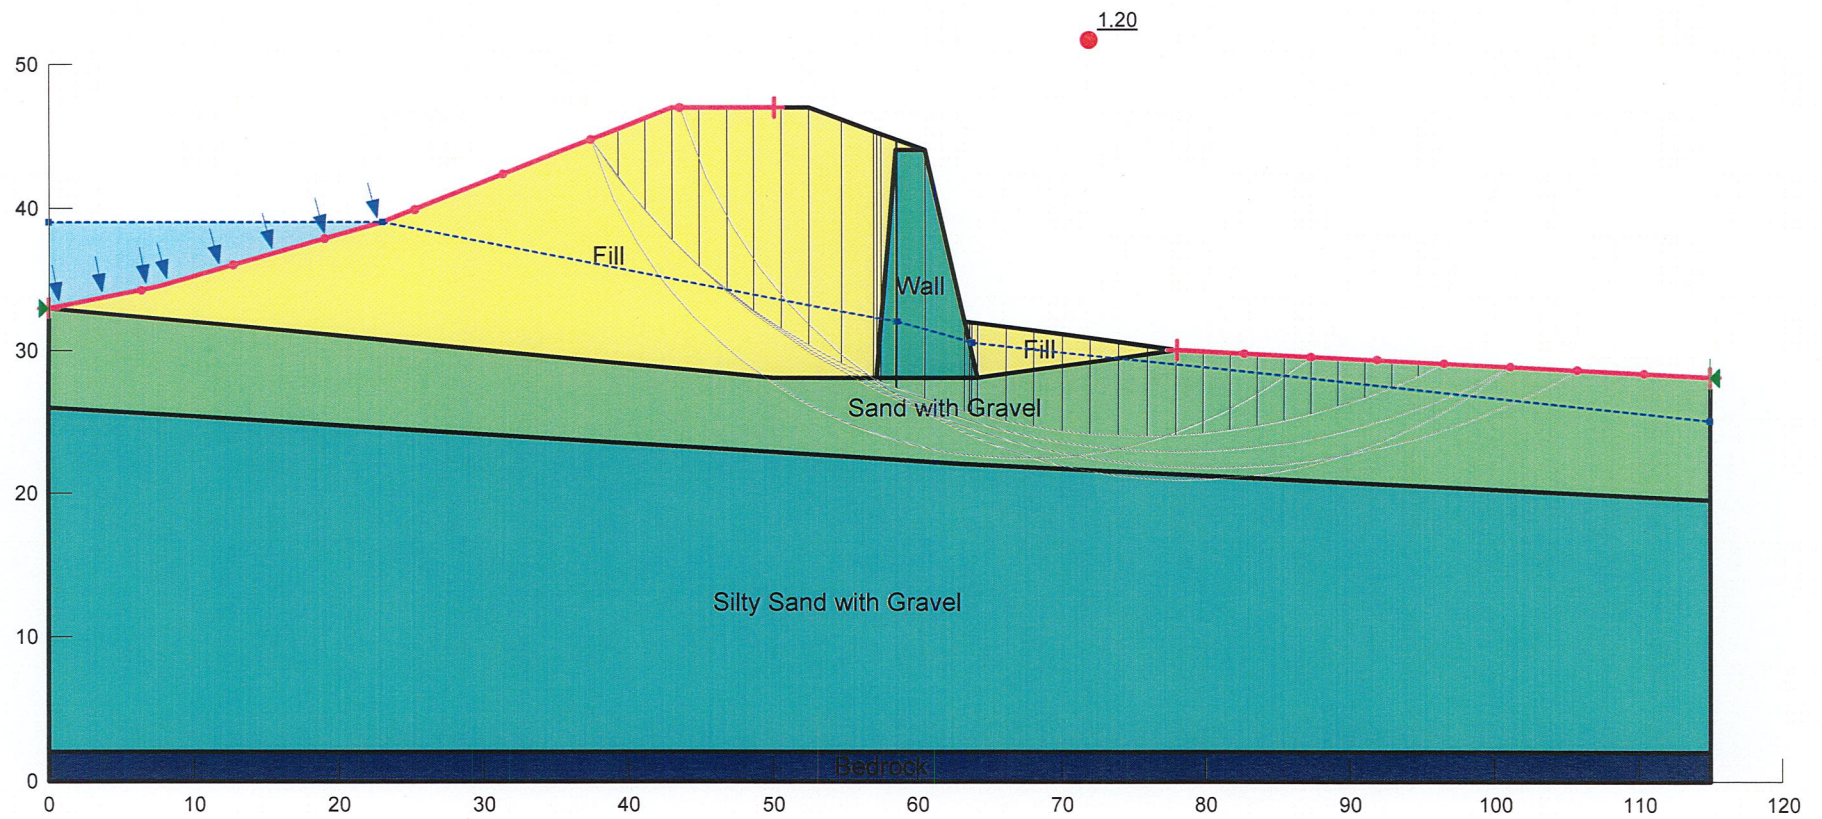
Figure D.6 - Max Embankment Retaining Wall Section
Proposed Conditions
Seismic: PGA = 0.12g

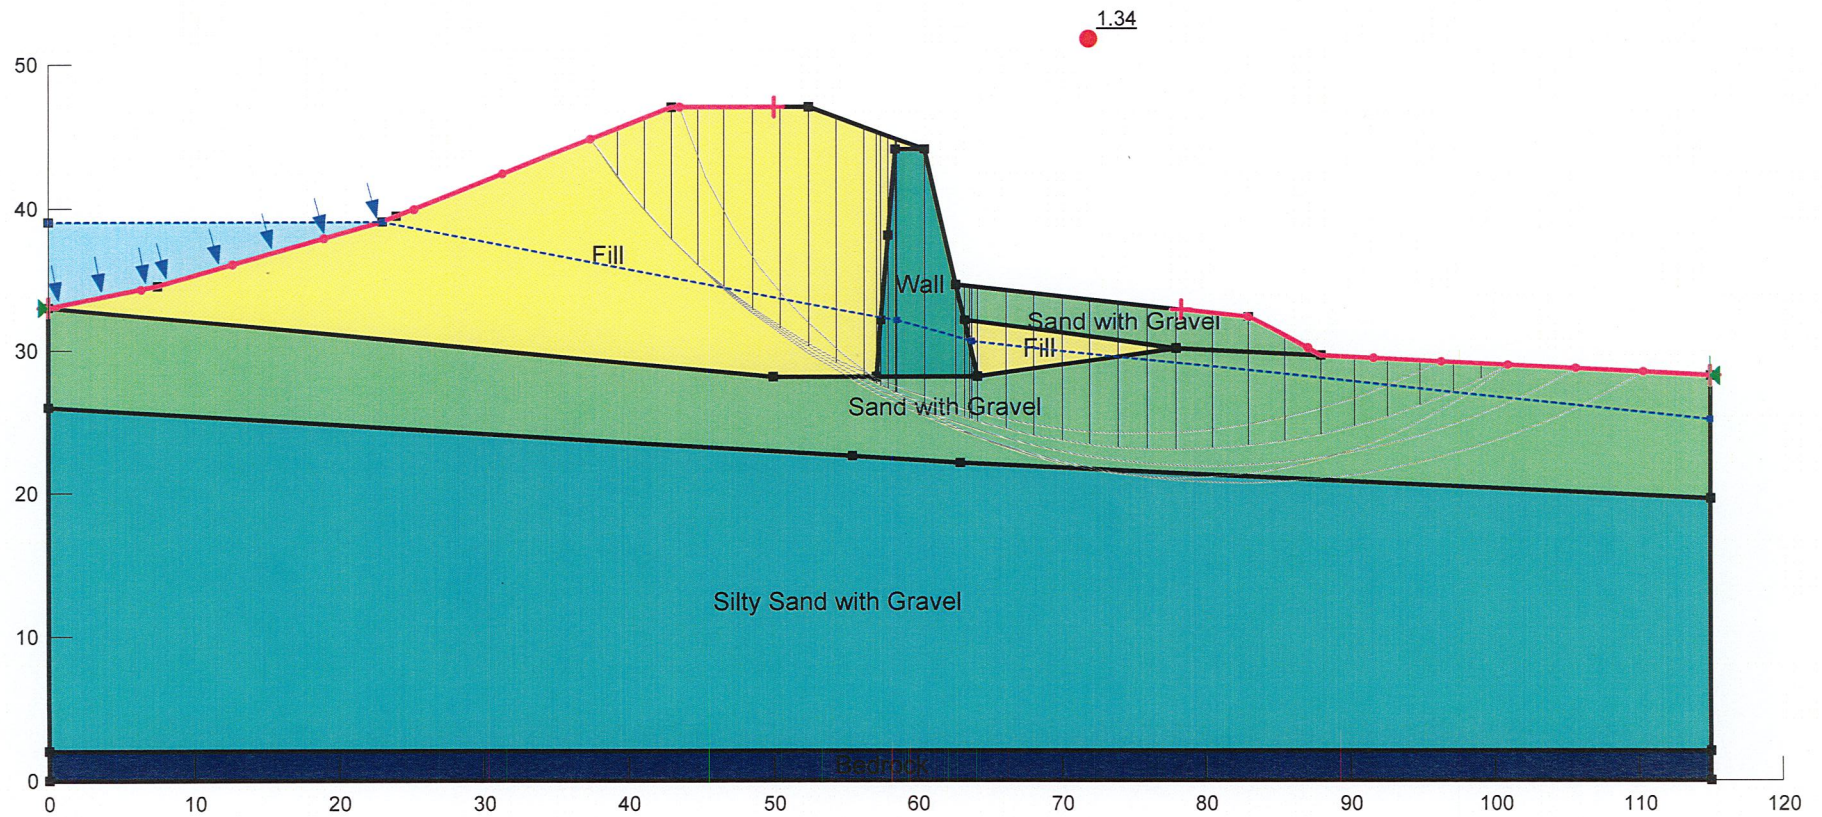
Figure D.7 - Max Embankment Retaining Wall Section
Proposed Conditions with 2.5' x 20' Berm
Seismic: PGA = 0.12g
