ADDENDUM NO. 1
February 28, 2023
225107

RE: ALBURGH VILLAGE WATER TANK REPLACEMENT

DECEMBER 17, 2009

***INSPECTION AND CLEANING OF THE VANTINE AVENUE
200,000-GALLON ELEVATED WELDED STEEL WATER STORAGE TANK***

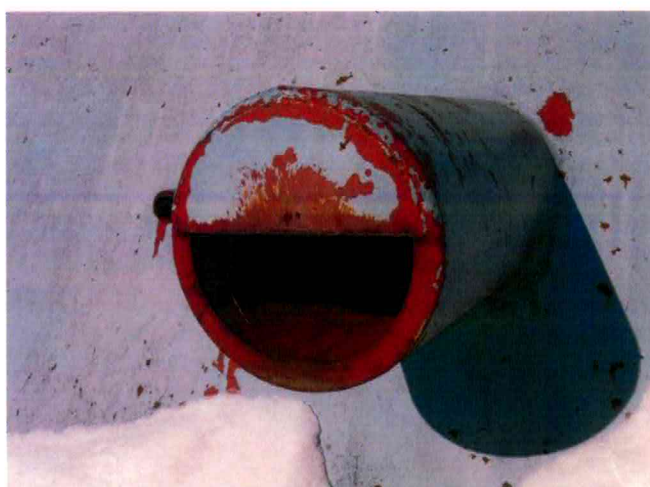
23 *Unscreened Overflow Pipe*
